GEOTECHNICAL COMPLETION REPORT STAGE 3

Lot 14 DP 374000 51 TE MAIKA ROAD, NGUNGURU

Job Details: Residential Subdivision – Stage Three

Job number: 20-0078
Client: Traverse Ltd

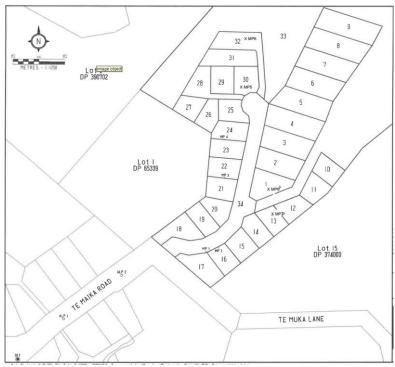
Figure 2 - View of subdivision showing location of settlement pads (Source R&B Ltd)

One pad (MP6) had an initial fall in height over the first month of 85mm. Consultation with R&B Ltd about this result with a consensus this reading is unlikely and was potentially instead caused by damage to the pad. Subsequent monthly changes in height for this pad have all been in the area of 10-13mm, in line with similar rates observed on the remaining pads.

Despite the significant separation between settlement pads, settlement rates is highly consistent across the development. MP6 shows the largest settlement over the last four weeks (6.9mm), with MP8 showing the least amount of settlement at 4.1mm. The use of the geocomposite fabric will also assist with any anomalies over the site and ensure a uniform amalgamation of the engineering fill.

Settlement pads are to continue to be monitored on a 3 monthly basis by Reyburn and Bryant, and shall remain in place over the next two years or until the allotments in which the pads occupy are developed and be supplied to CES Ltd so that potential options for shallow foundations can be considered for any site-specific developments, subject to specific engineering design. This information can then be used to assist any future site-specific development of each site.

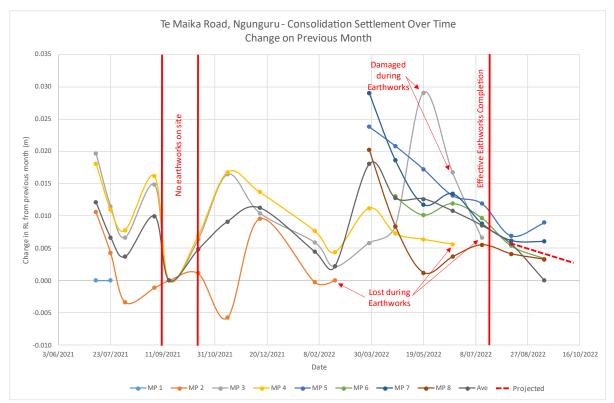
Figure 3 - Graph measuring the rate of change in movement (settlement) from the previous period.RL heights for each of the settlement pads is taken every four weeks and the change from the previous period graphed. (Source CES Ltd)

It is noted that when earthworks stopped during September 2021 and no heavy machinery was working on-site that no significant movement occurred on site. In most instances, settlement ceased, which is a similar observation with recent levels at the site towards the end of the development reducing on a downward trend as site works reduce and heavy machinery leaves the site.

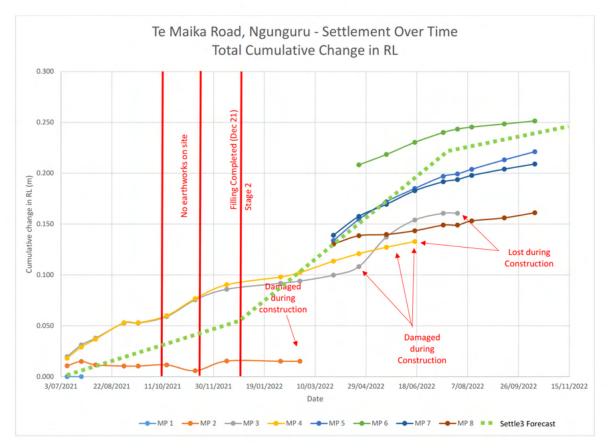
Figure 4 - Graph showing the total movement (settlement) from the installation of the settlement pads. (Source CES Ltd)

Total settlement-induced movement at any individually monitored pad on the subdivision has generally been less than 250mm, with the rate of change noticeably reducing from July 2022 onwards (1.5 years post earthworks).

The above results have been included in Figure 4, which shows a comparison to the observed total settlement levels measured on-site. From a comparison of the measured and calculated settlement rates, the rates have generally been consistent, with potentially 50mm of additional movement likely expected with the additional loading from residential development. A further assessment of the settlement was conducted without the 12kPa loading from residential development; this resulted in overall long-term settlement rates being significantly lower.

From the site observations and settlement analysis of both theoretical and observed, CES Ltd is satisfied that the earth fill is within the secondary settlement phase, with rates of settlement gradually decreasing over the coming year. At the current stage, any immediate residential development on the engineered fill shall be suspended and piled to avoid further surcharging to the engineered fill. Piles will need to be pre-augured through the engineered fill and geocomposite to ensure piles extend below the engineered fill layer.
