EARTHWORK COMPLETION REPORT

PREPARED FOR TRAVERSE LTD

AT 373 KERIKERI ROAD, KERIKERI

LOT 1 DP 25752

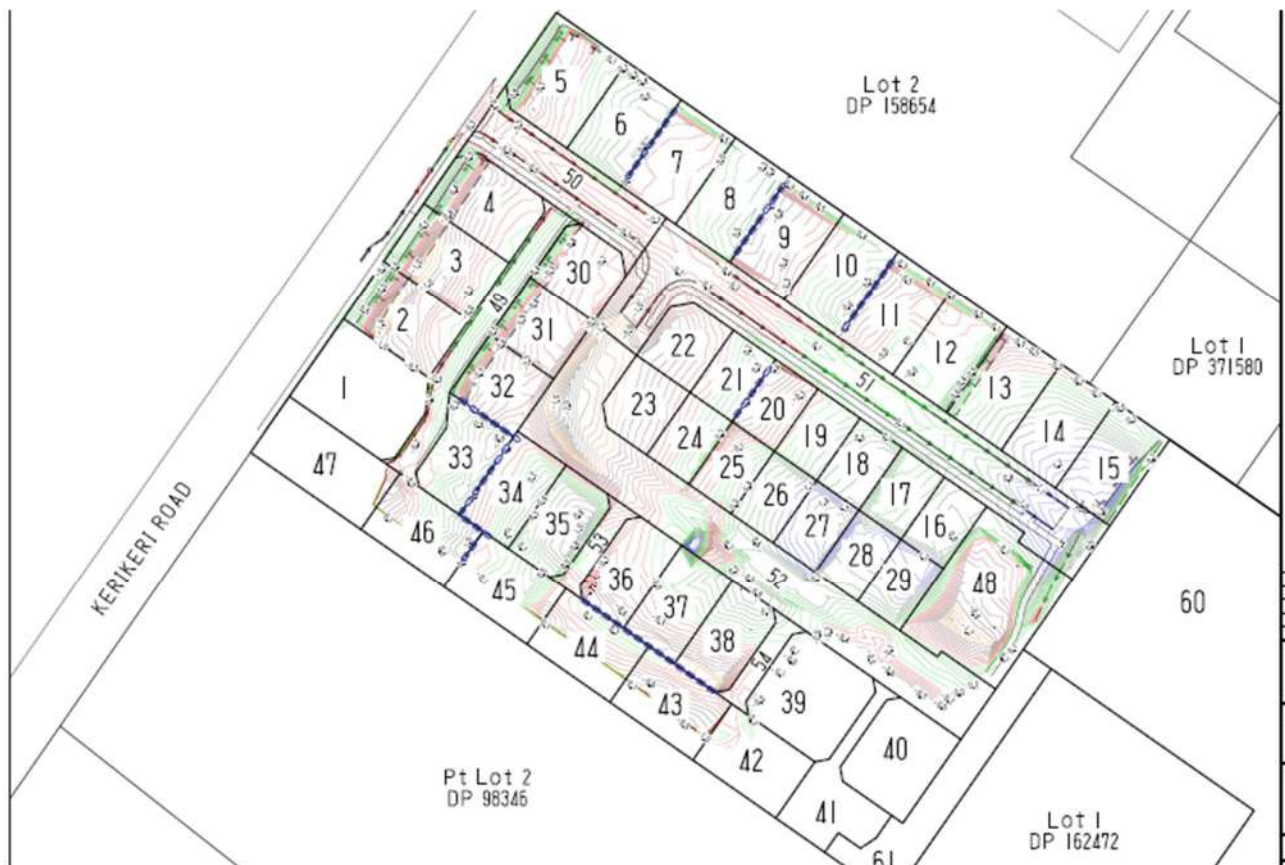
Figure C - As-Built Earthworks drawings (Source: Sheet 02, EWA16655 R&B Drawings). Green and blues indicate the extent of fill, and oranges and red excavation. Blue lines show the location of the Magnum stone retaining walls.

Earthworks over the property comprised excavation to depths no more than 2.0m and filling up to 1.8m. A balance of excavation and filling was undertaken to form suitable gradients for future residential development.

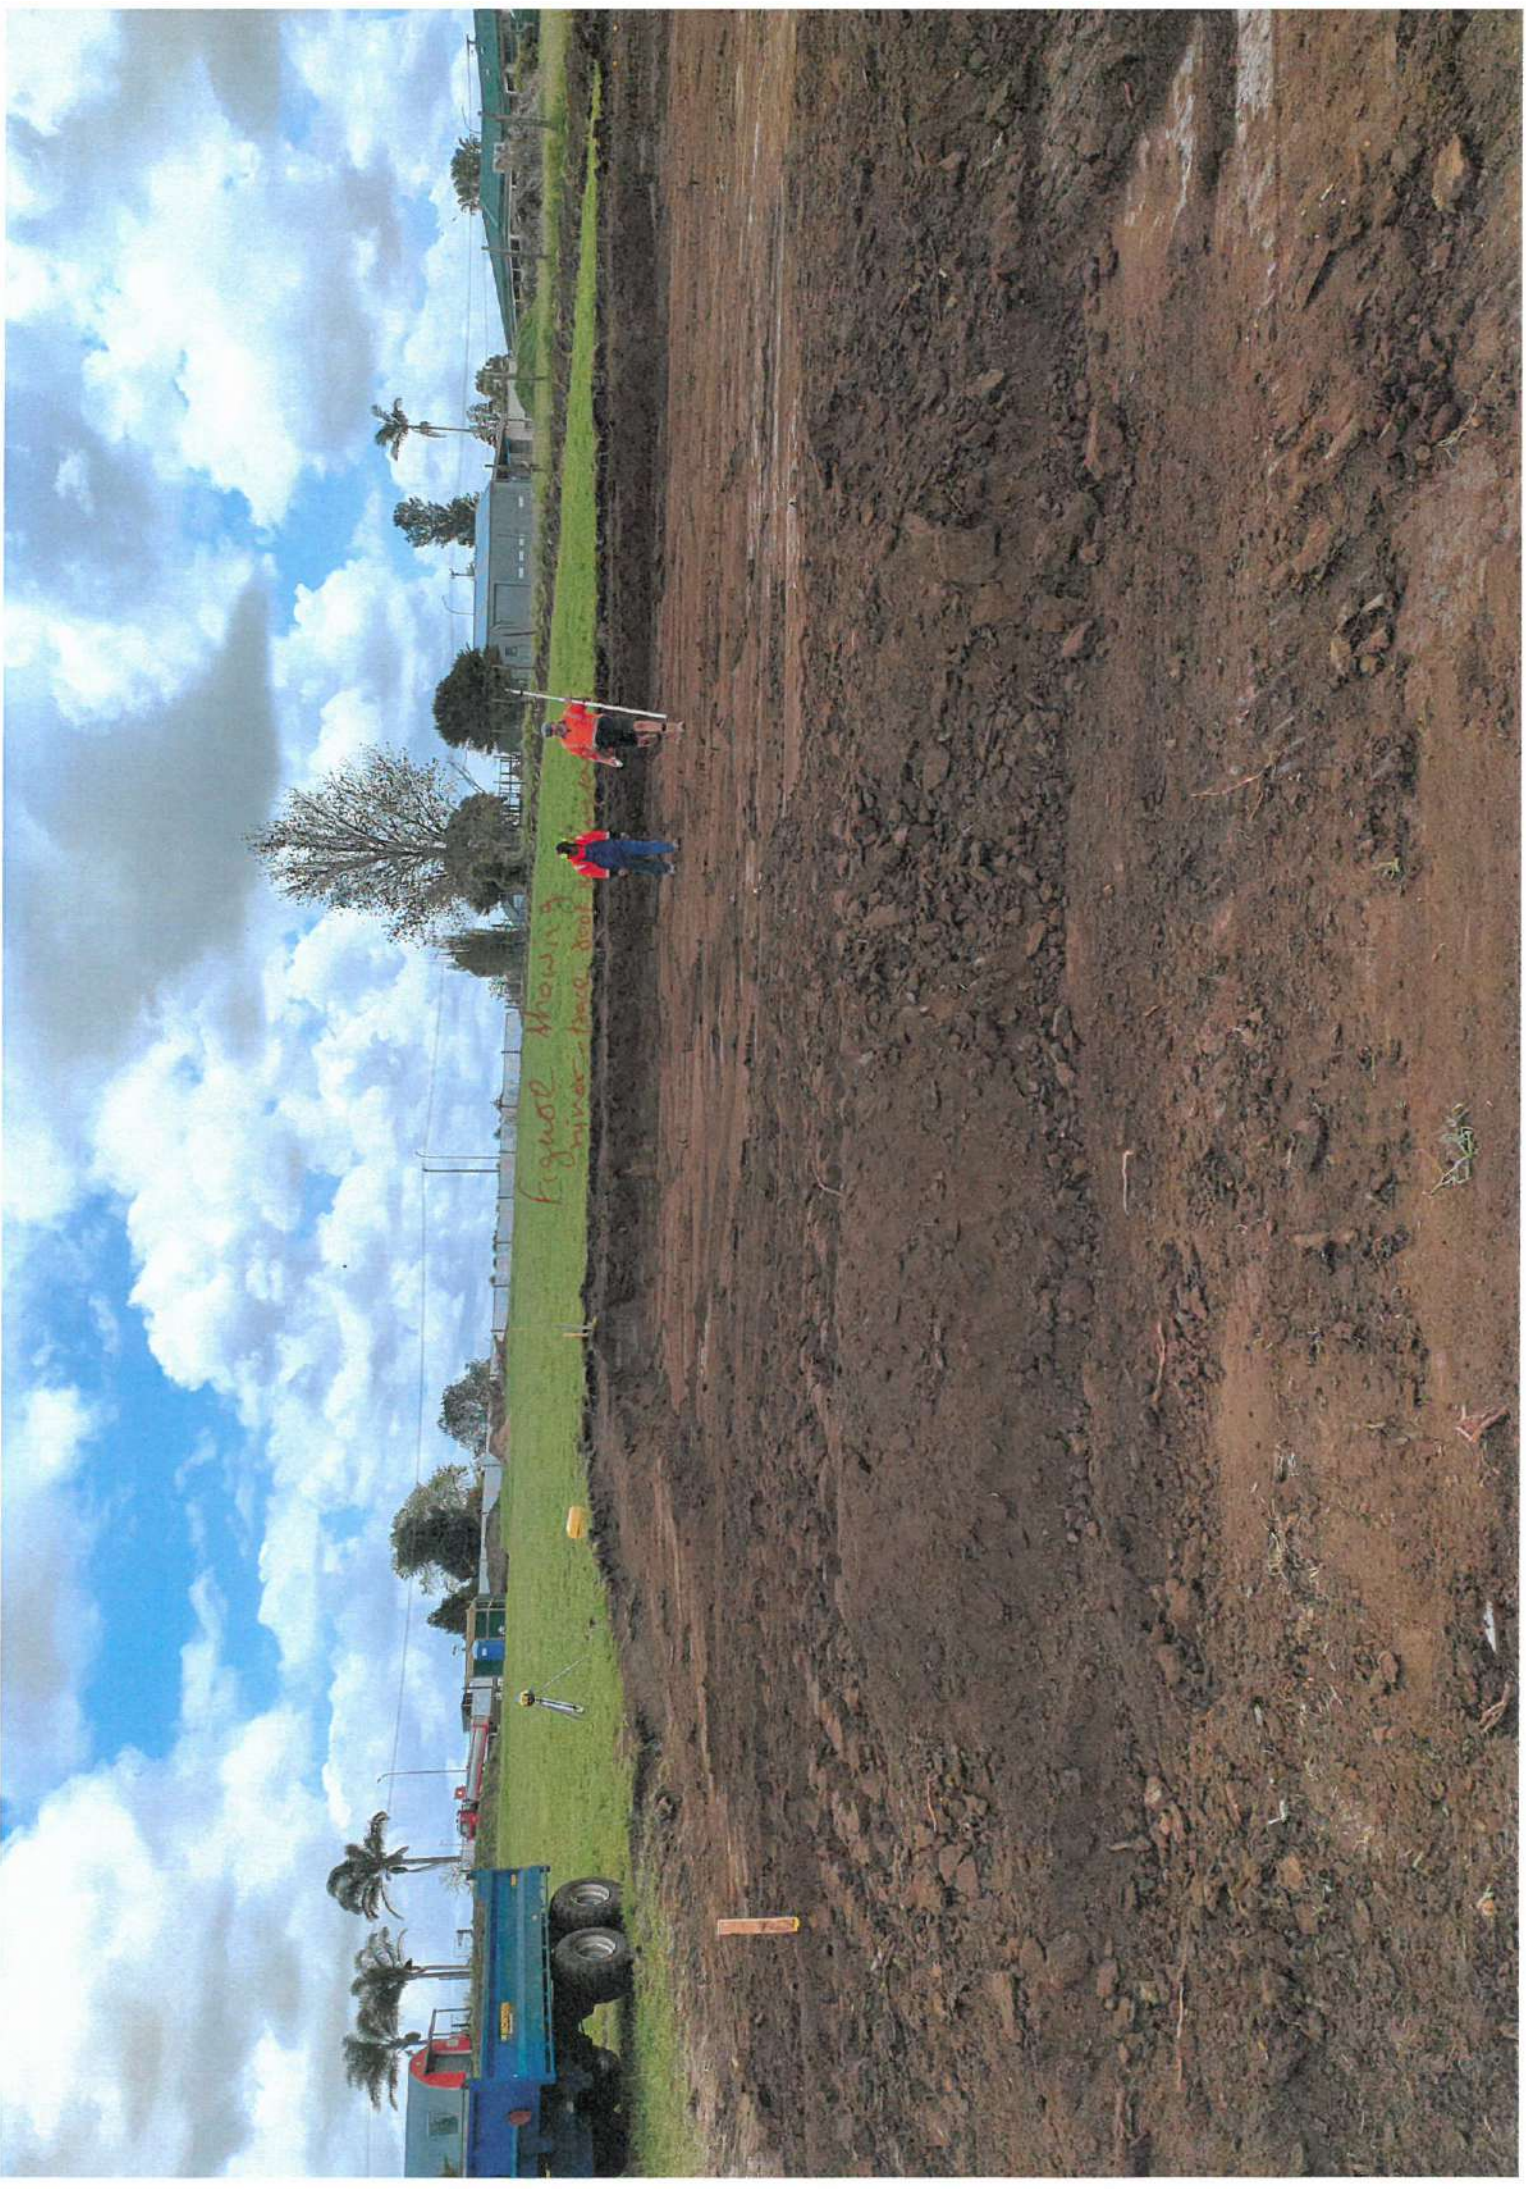
Figure showing
minor base rock

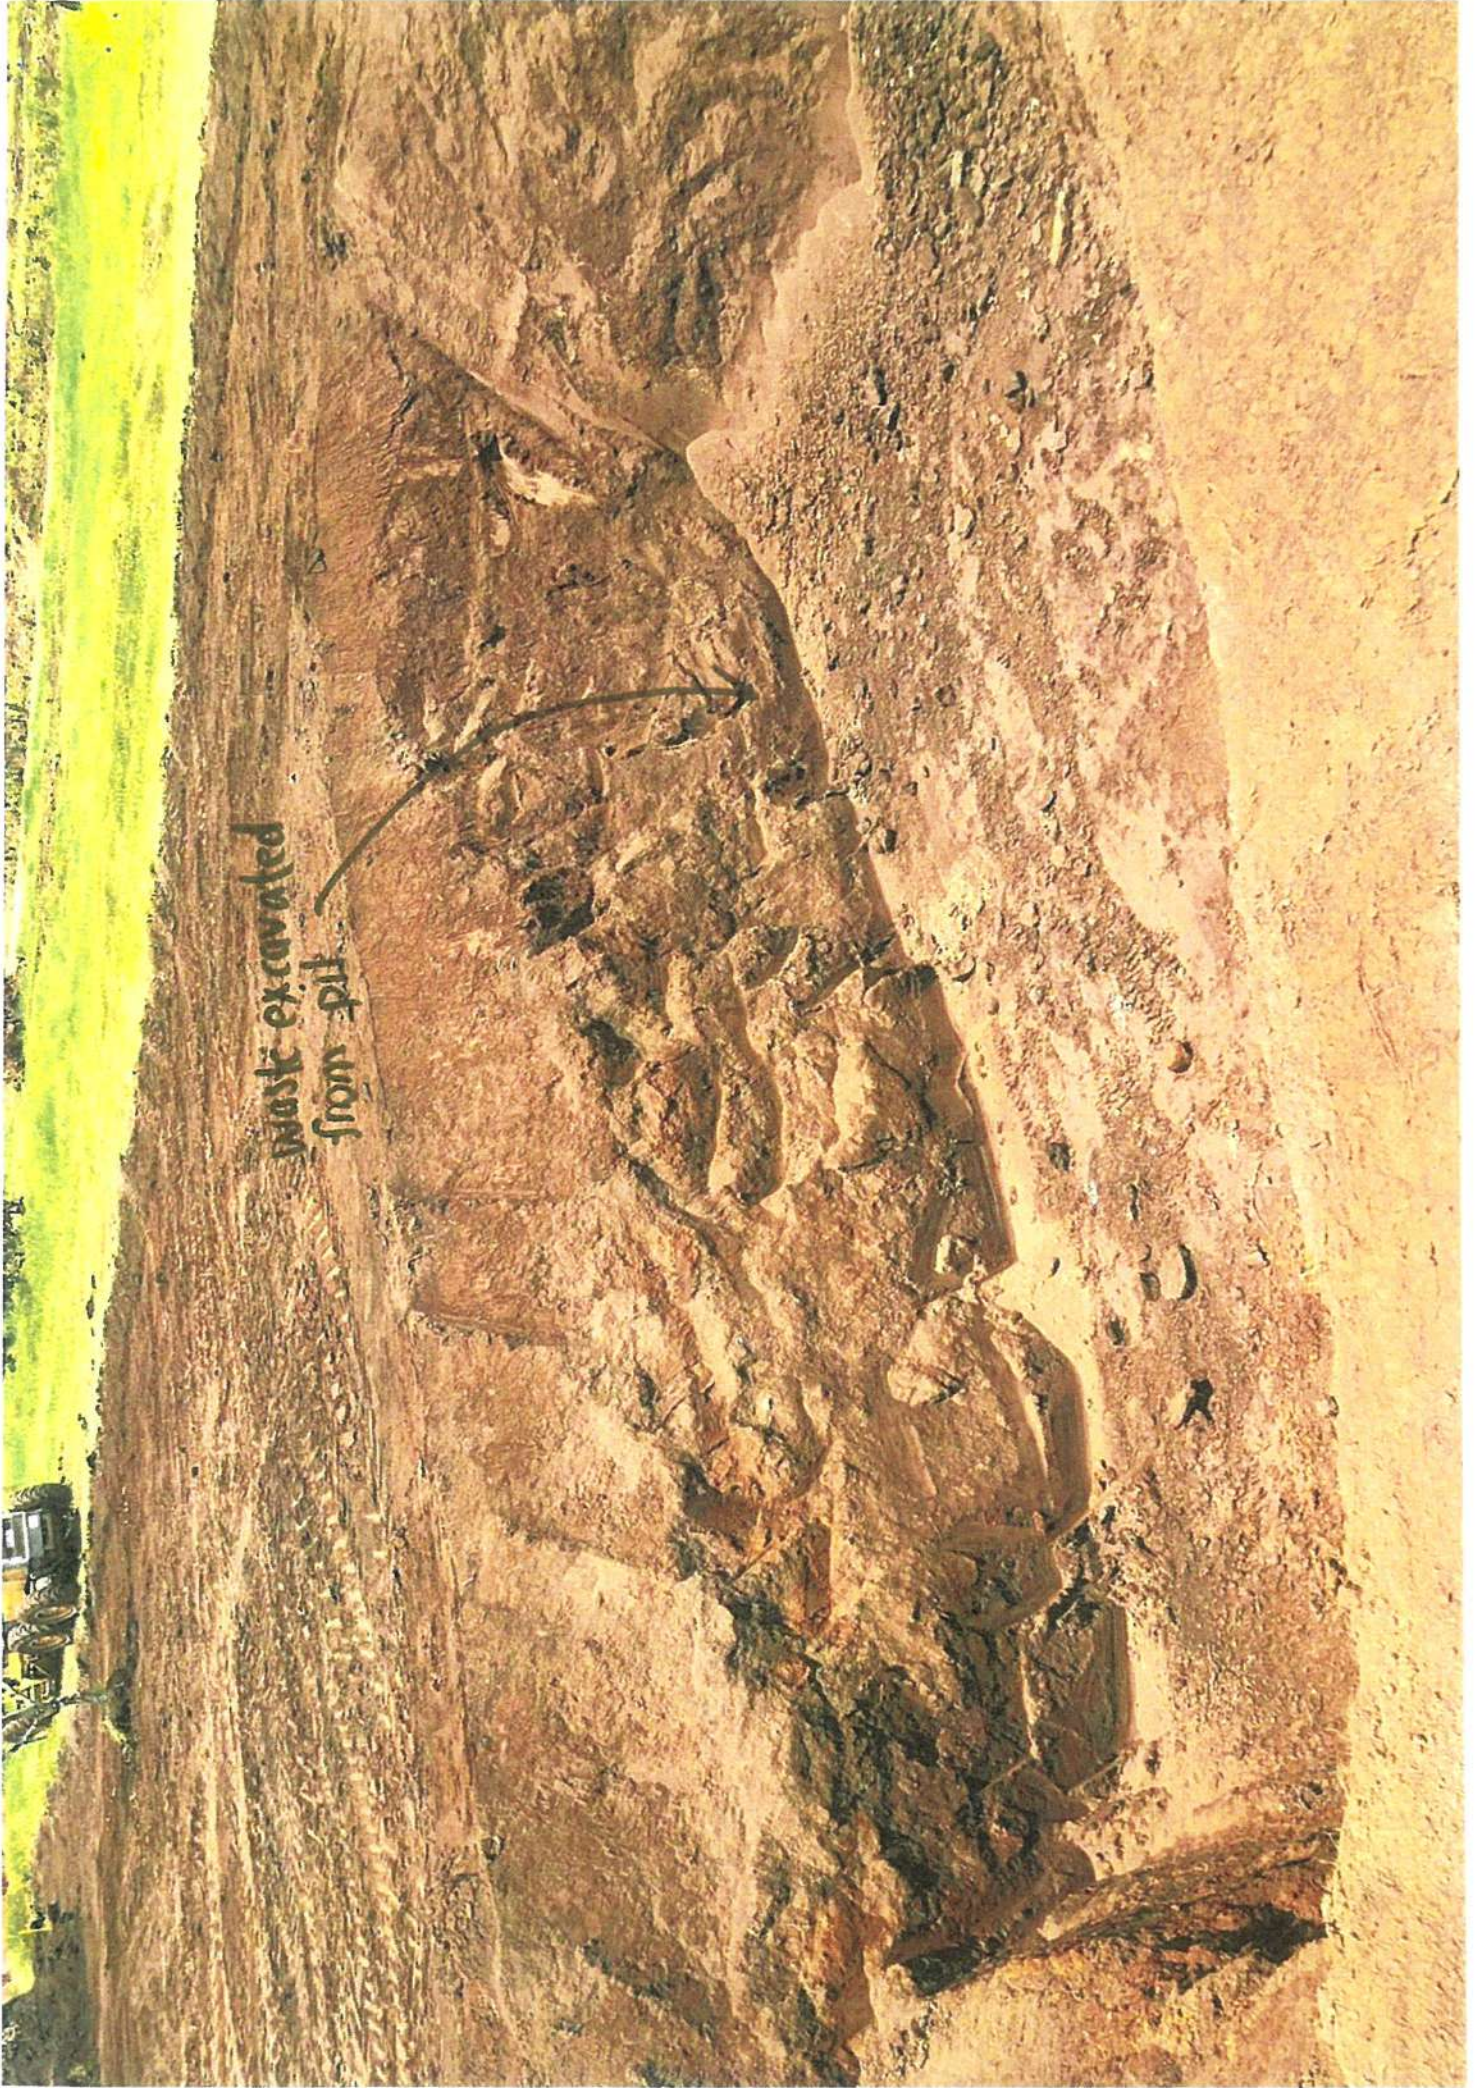
waste excavated
from pit

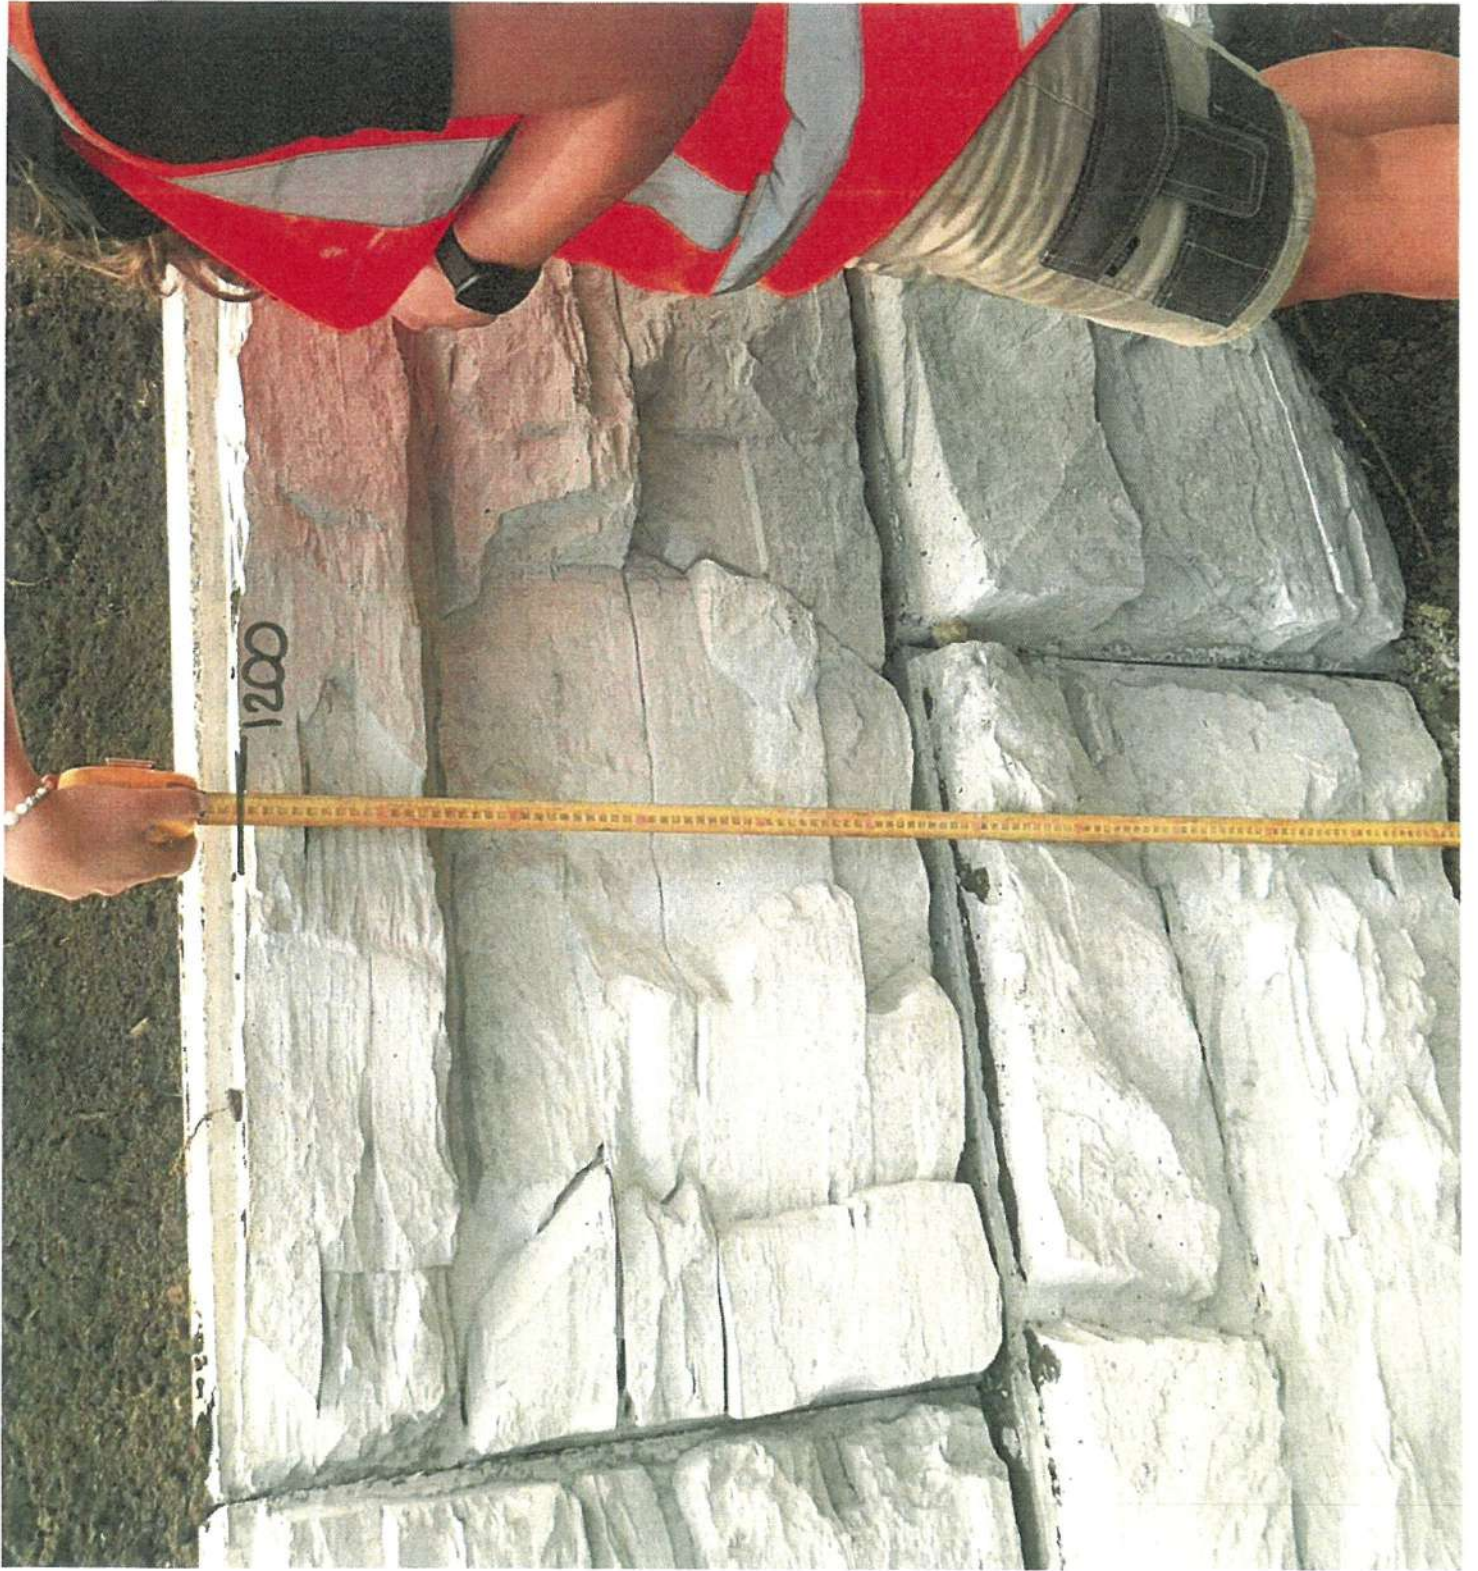
height of 2x retaining wall blocks
