GEOTECHNICAL COMPLETION REPORT STAGE 1

Lot 14 DP 374000 51 TE MAIKA ROAD, NGUNGURU

Job Details: Residential Subdivision – Stage One

Job number: 20-0078
Client: Traverse Ltd

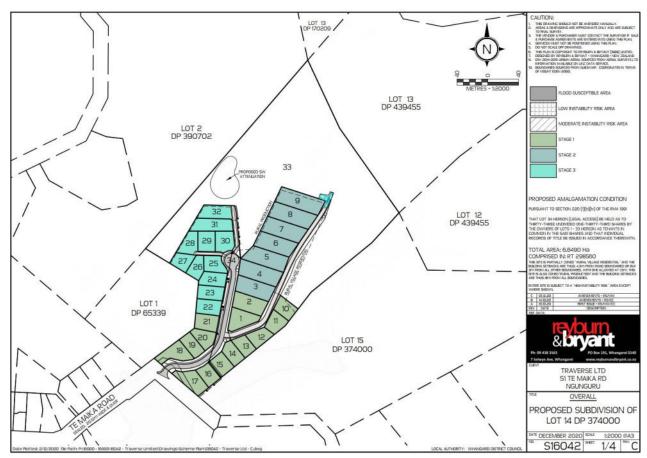
Figure 1 - Map of subdivision, showing various Stages. (Source R&B Ltd)

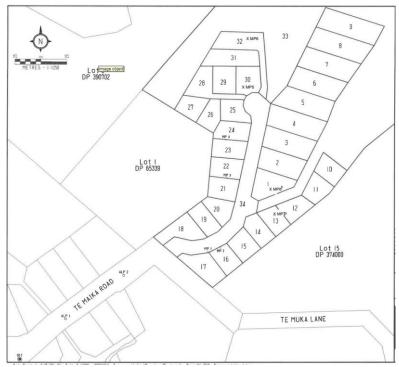
Figure 2 - View of subdivision showing location of settlement pads (Source R&B Ltd)

One pad (MP6) had an initial fall in height over the first month of 85mm. Consultation with R&B Ltd about this result with a consensus this reading is unlikely and was potentially instead caused by damage to the pad. Subsequent monthly changes in height for this pad have all been in the area of 10-13mm, in line with similar rates observed on the remaining pads.

Settlement pads are to continue to be monitored on a 3 monthly basis by Reyburn and Bryant, and shall remain in place over the next two years or until the allotments in which the pads occupy are developed and be supplied to CES Ltd so that potential options for shallow foundations can be considered for any site-specific developments, subject to specific engineering design. This information can then be used to assist any future site-specific development of each site.

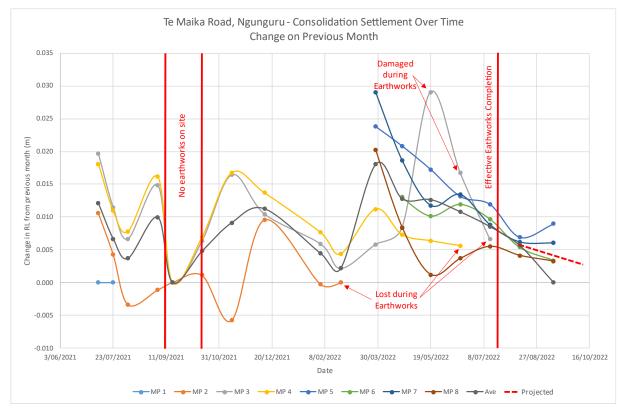
Figure 3 - Graph measuring the rate of change in movement (settlement) from the previous period.RL heights for each of the settlement pads is taken every four weeks and the change from the previous period graphed. (Source CES Ltd)

It is noted that when earthworks stopped during September 2021 and no heavy machinery was working on-site that no significant movement occurred on site. In most instances, settlement ceased, which is a similar observation with recent levels at the site towards the end of the development reducing on a downward trend as site works reduce and heavy machinery leaves the site.

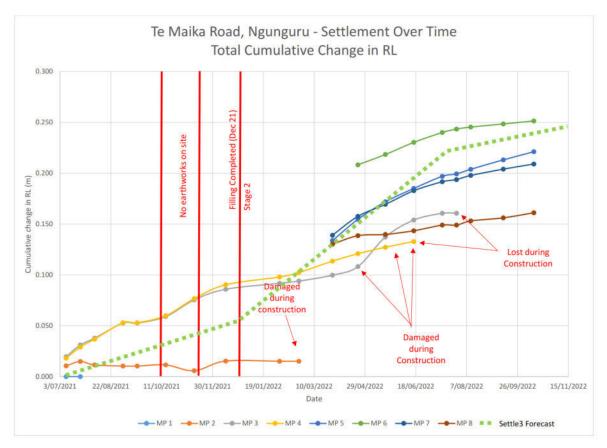
Figure 4 - Graph showing the total movement (settlement) from installation of the settlement pads. (Source CES Ltd)

Total settlement-induced movement at any individually monitored pad on the subdivision has generally been less than 250mm with the rate of change noticeably reducing from July 2022 onwards (1.5 years post earthworks).

The above results have been included in Figure 4, which shows a comparison to the observed total settlement levels measured on-site. From a comparison of the measured and calculated settlement rates, the rates have generally been consistent, with potentially 50mm of additional movement likely expected with the additional loading from residential development. A further assessment of the settlement was conducted without the 12kPa loading from residential development; this resulted in overall long-term settlement rates being significantly lower.

From the site observations and settlement analysis of both theoretical and observed, CES Ltd is satisfied that the earth fill is within the secondary settlement phase, with rates of settlement gradually decreasing over the coming year. At the current stage, any immediate residential development on the engineered fill shall be suspended and piled to avoid further surcharging to the engineered fill. Piles will need to be pre-augured through the engineered fill and geocomposite to ensure piles extend below the engineered fill layer.

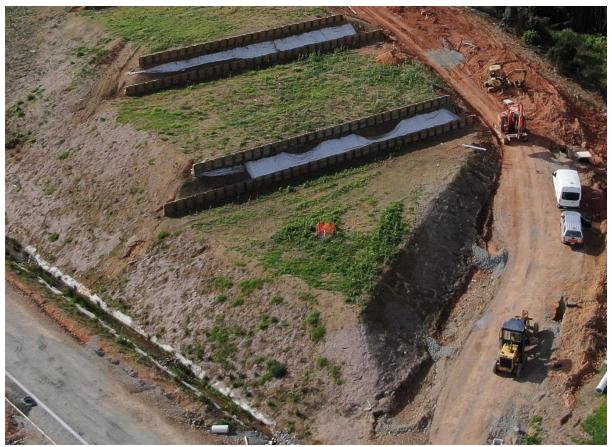
Figure 5 - Lot 1 and Lot 2 during the construction phase . Note the location of the retaining walls and batters on the left and right hand sides (west and east). Source CES Ltd.

It is recommended that only limited site formation works take place immediately in front (downslope) of any retaining walls. Any works that require excavation greater than 0.5m deep should be subject to a specific engineering design to ensure that retaining walls are not undermined. Further to this, it is recommended that a minimum setback of 1.5m from the downslope retaining wall be applied for any future development. To illustrate the building setback, a 'Restricted Development Area Plan' has been prepared by CES Ltd and is appended to this report, refer to Appendix 4. Restricted Development Areas are discussed in further detail within Section 5.12 below.

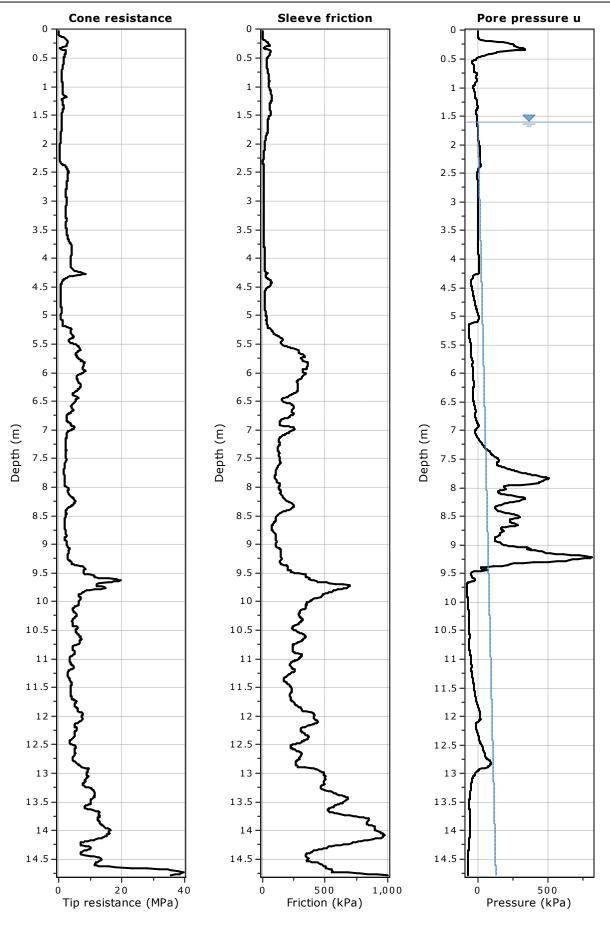
CPT: cpt 1 lot 17

Total depth: 14.78 m Coords: lat -35.62615° lon 174.516722°
