GEOTECHNICAL COMPLETION REPORT STAGE 2

Lot 14 DP 374000 51 TE MAIKA ROAD, NGUNGURU

Job Details: Residential Subdivision – Stage Two

Job number: 20-0078
Client: Traverse Ltd

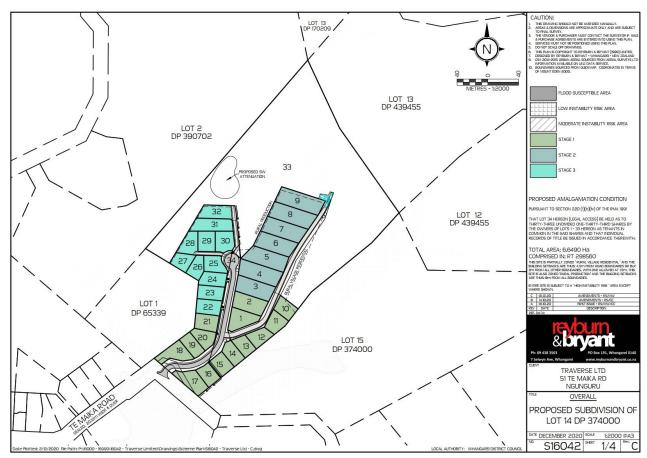
Figure 1 - Map of subdivision, showing various Stages. (Source R&B Ltd)

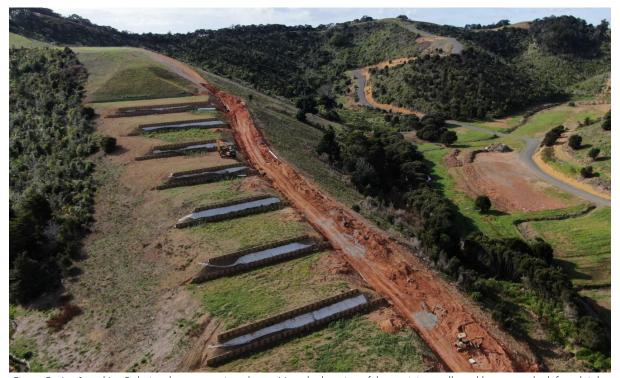
Figure 2 - Lot 1 and Lot 2 during the construction phase. Note the location of the retaining walls and batters on the left and right-hand sides (west and east). Source CES Ltd.

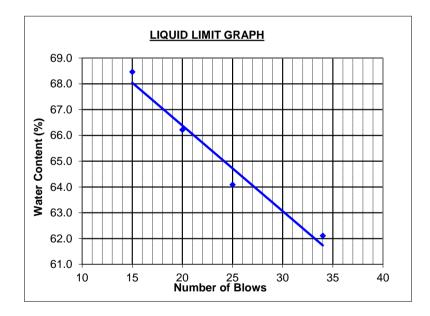
Description of Sample: Clayey SILT, traces of fine sands and rootlets, light red brown with black veins, moist

NWC	46.5
Liquid Limit	65
Plastic Limit	38
Plasticity Index	27
