Inspection Report

Project: Traverse Earth works monitoring

Client: Traverse Ltd

**Appendix D – Geotechnical Report “GEOTECHNICAL REPORT
FOR PROPOSED SUBDIVISION – Prepared for Traverse Ltd at
373 Kerikeri Road, Kerikeri”**

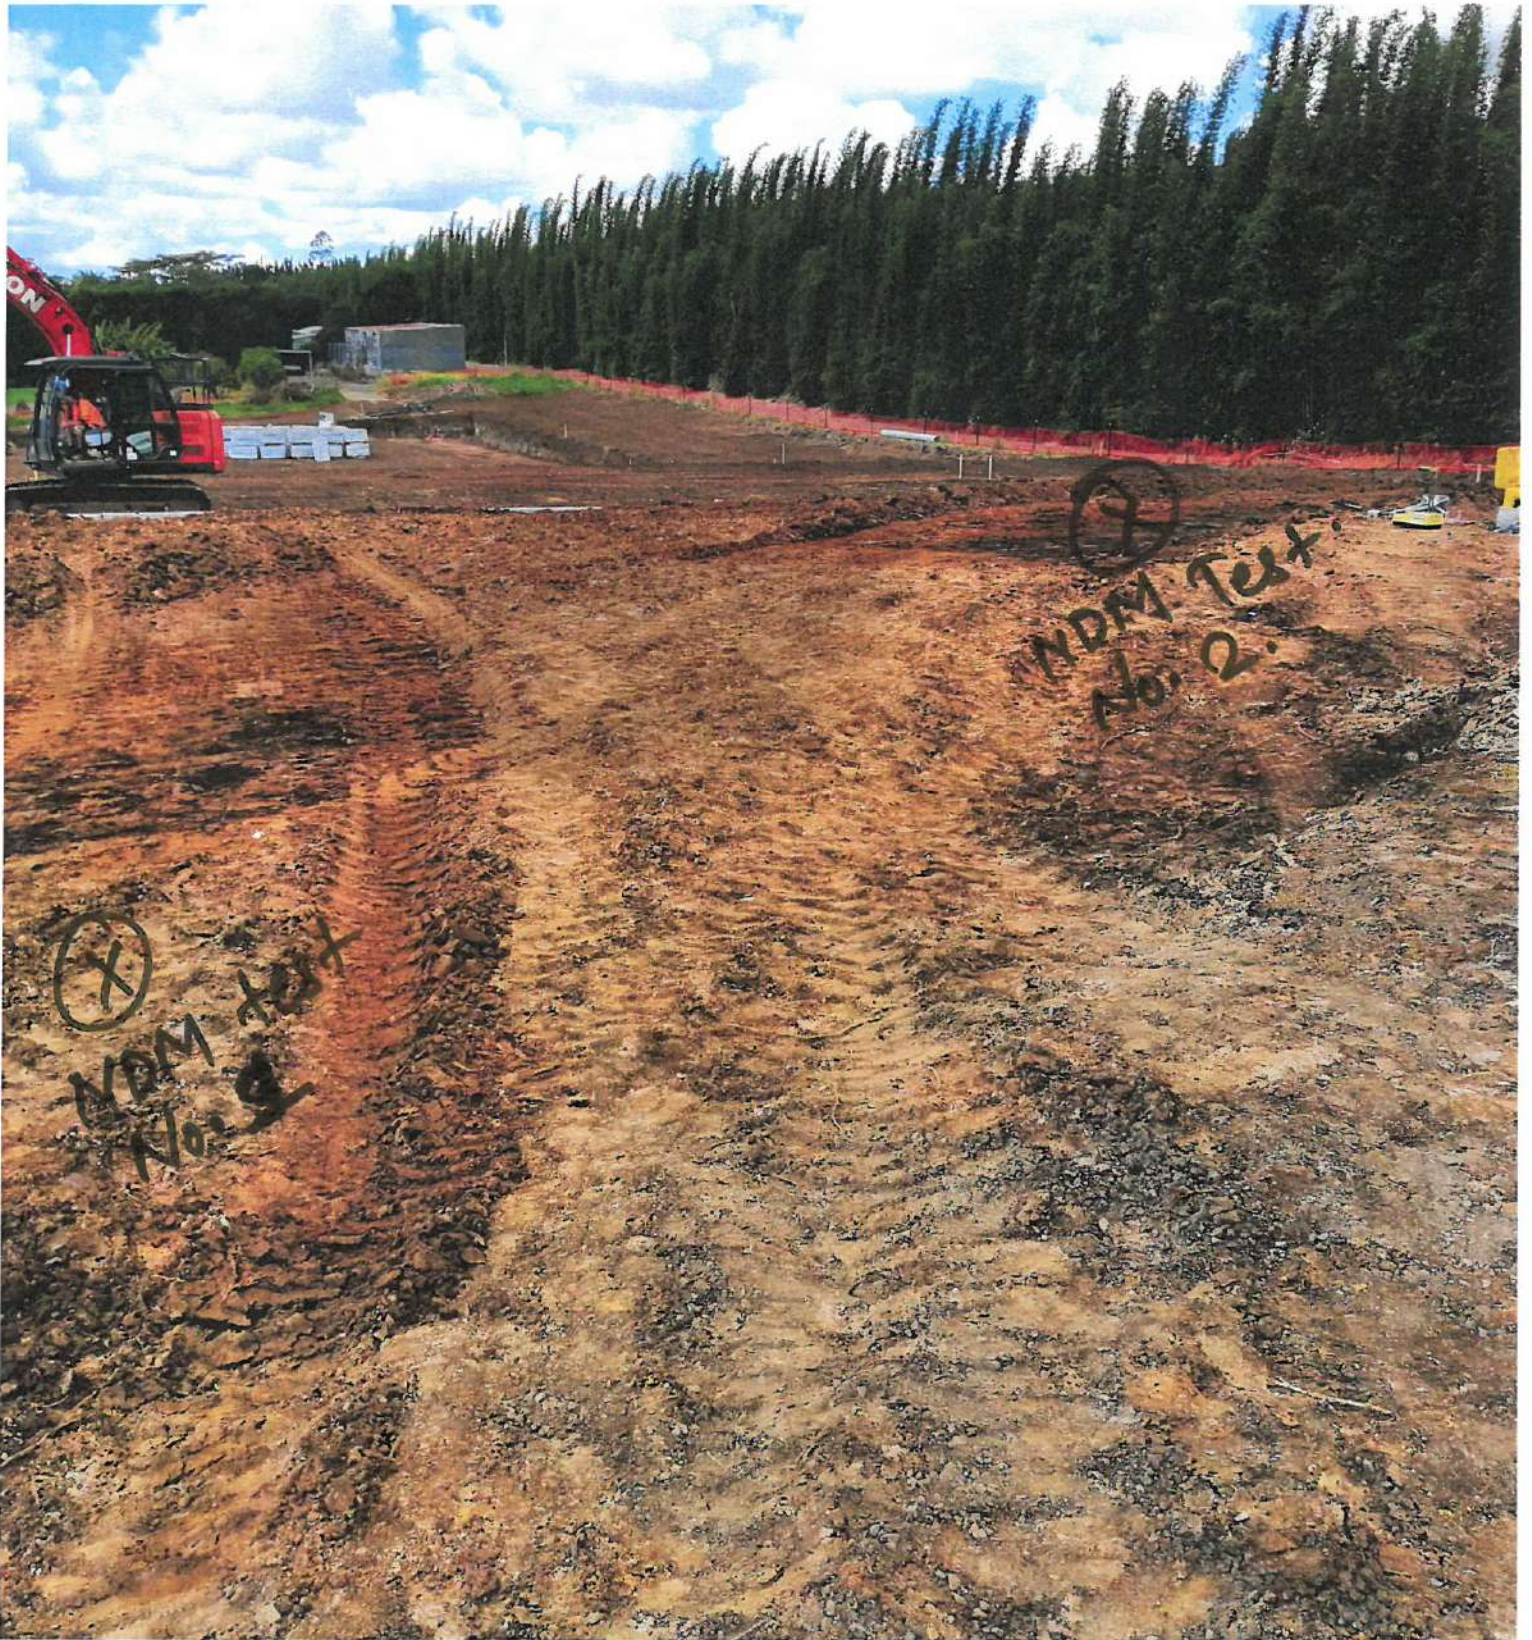
NDM Test
No. 2.

NDM Test
No. 1.

- * NDM tests were pass OK to proceed.
- * Excavation face along the northern boundary, next to wall B within Lot 7, Lot 9 & Lot 11, are standing vertical some 1.2m to 1.5m high. These excavation faces needs to be retained.

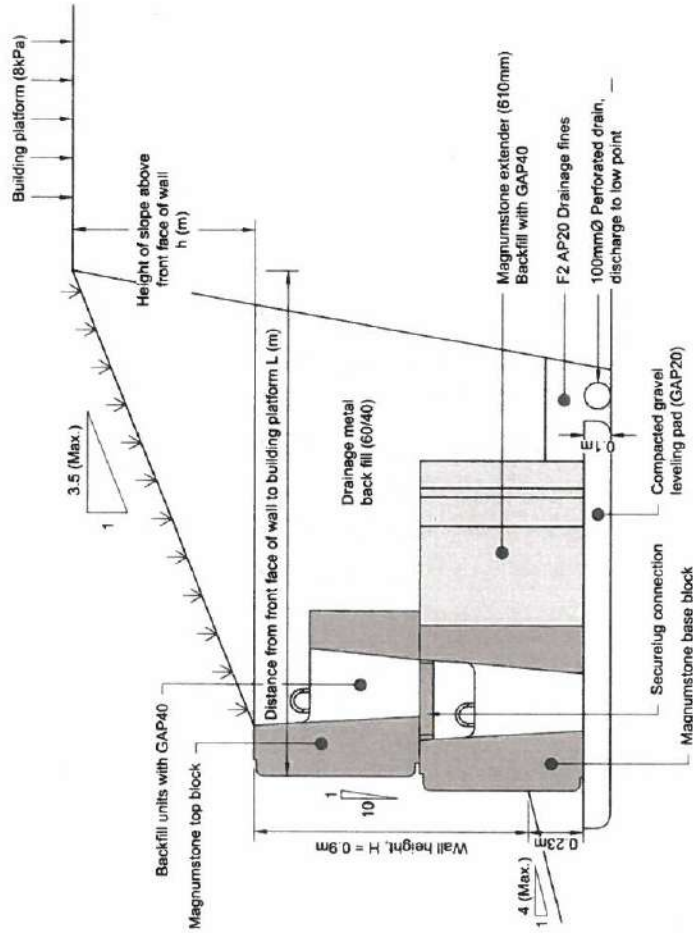
TYPICAL RETAINING WALL CROSS SECTION - WITH EXTENDER BLOCK
NOT TO SCALE
(WALLS A, B, C, F & H)

Wall	L (m)	h (m)
A	0.75	0.2
B	1.25	0.4
C	1.25	0.4
F	1.25	0.4
H	1.5	0.4

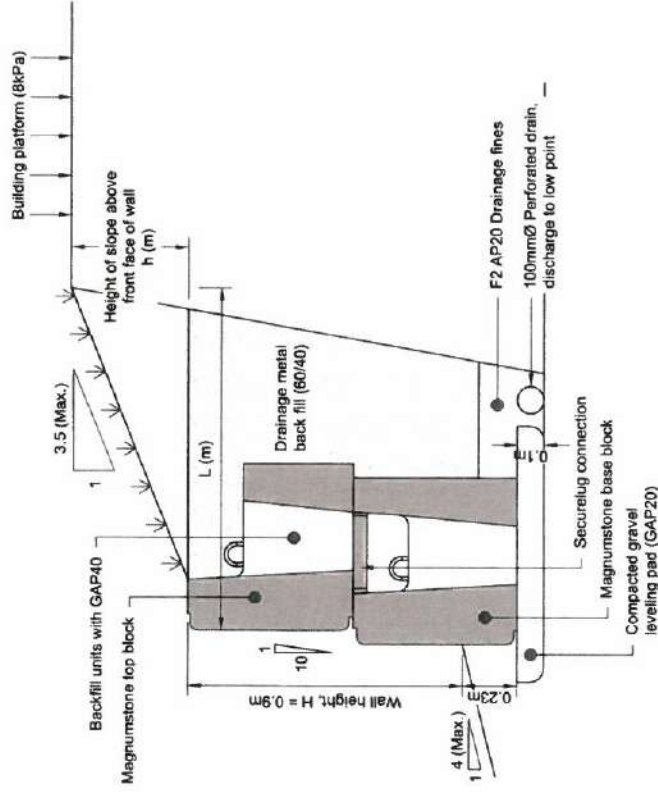
TYPICAL RETAINING WALL CROSS SECTION - WITHOUT EXTENDER BLOCK
NOT TO SCALE
(WALLS D, E & G)

Wall	L (m)	h (m)
D	2.0	0.6
E	1.75	0.5
G	2.25	0.65

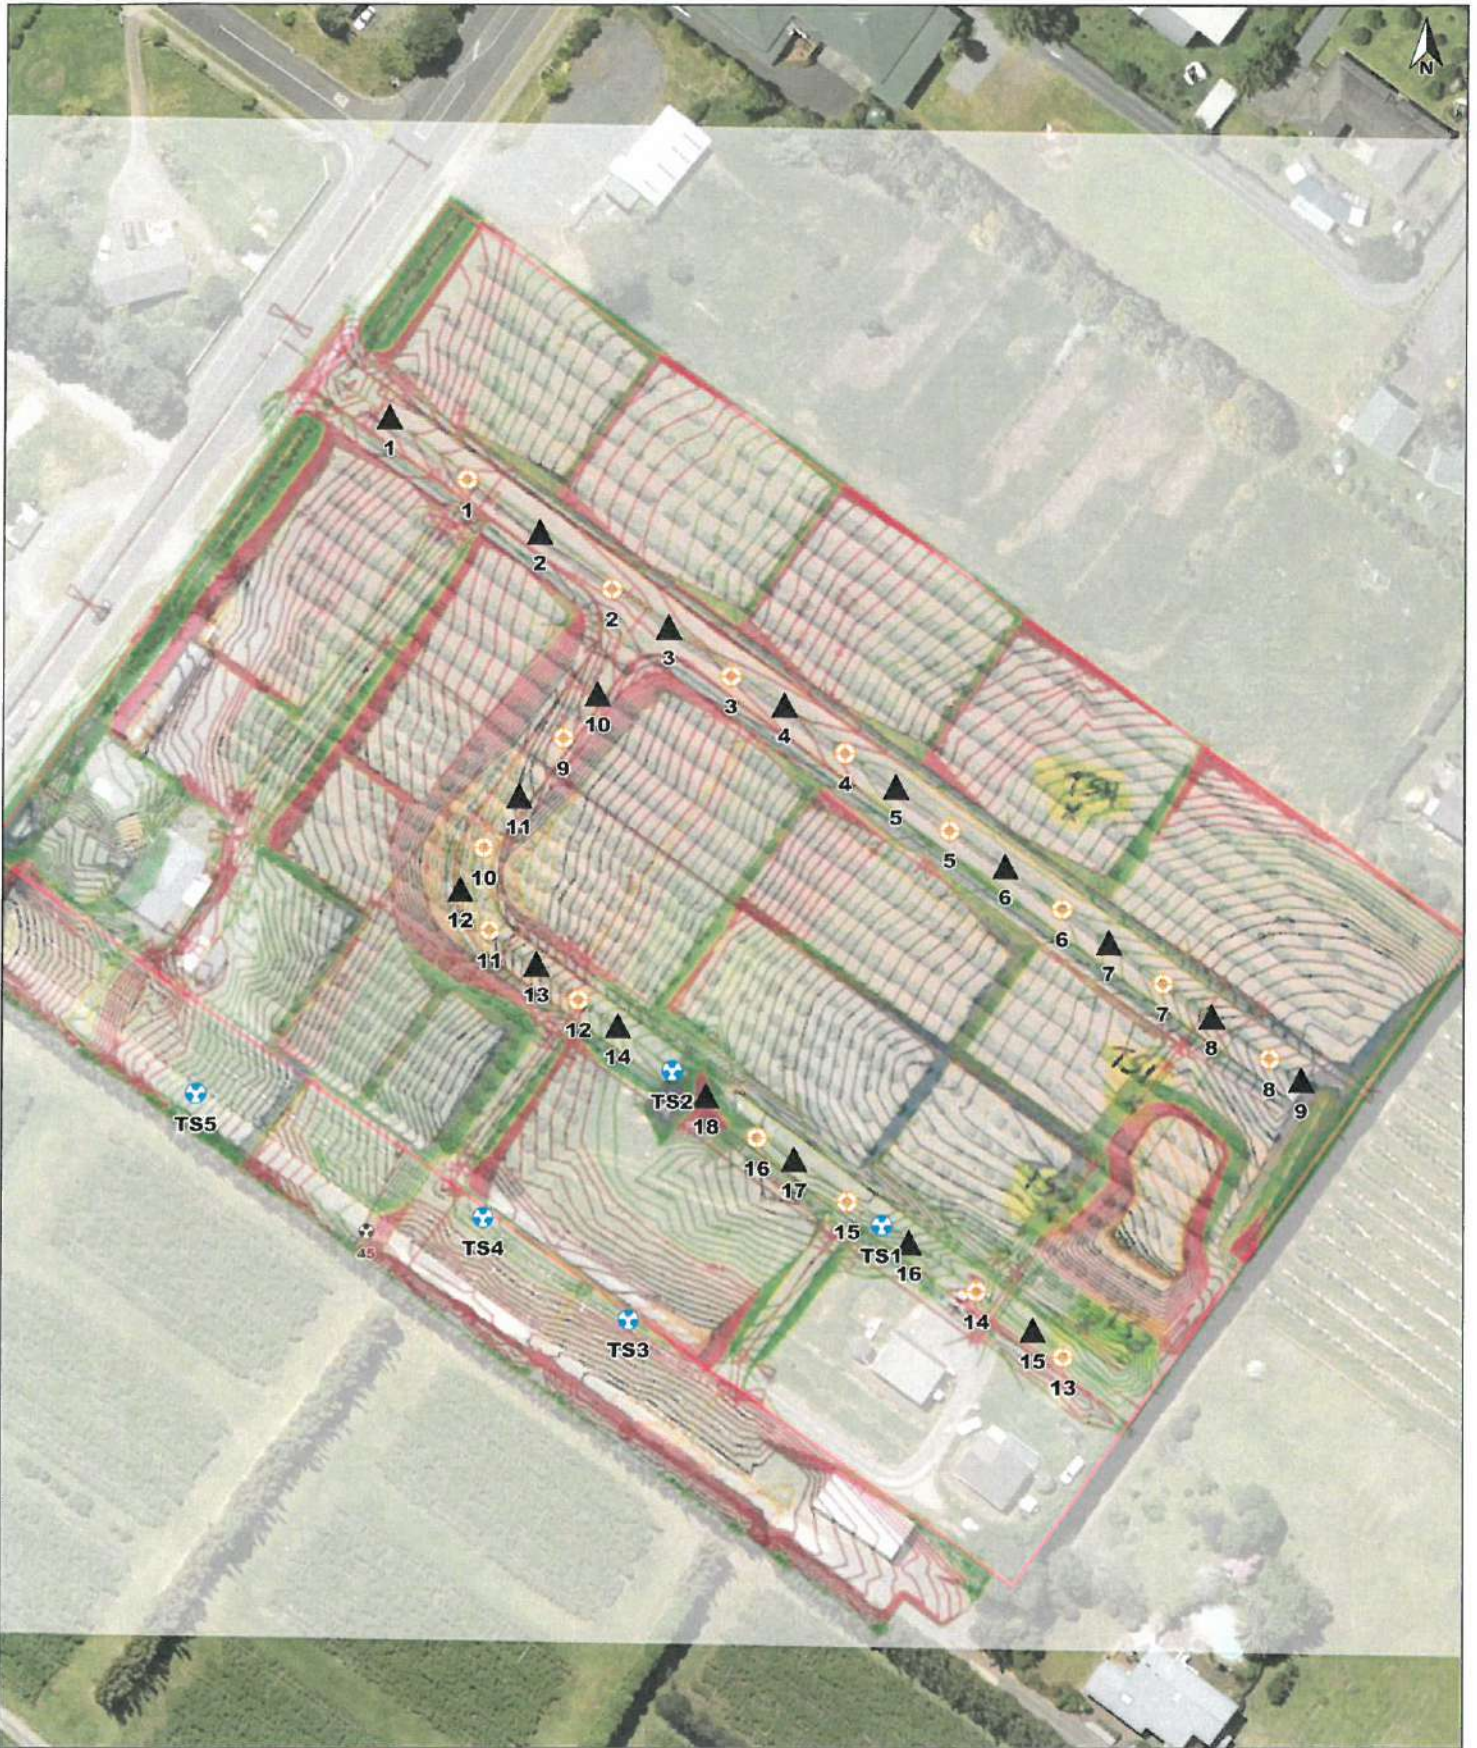
Title: Untitled Figure		
Client: Traverse Developments		
Project: Traverse - KeriKeri	Drawn:	Figure No.:1 Size: A4
Date:	Checked:	
Proj No.: 12546	Scale: 1:1317	Version:

<u>SC1</u> 7,6,6,7,7	<u>CBR1</u> 22-23	<u>SC2</u> 6,6,7,6,7	<u>CBR2</u> 24-27	<u>SC3</u> 7,6,6,7,7	<u>CBR3</u> 24-25
SC2					
<u>SC4</u> 8,4,6,6,7	<u>CBR4</u> 24	<u>SC5</u> 7,5,6,6,7	<u>CBR5</u> 25-26	<u>SC6</u> 6,6,7,7,9	<u>CBR6</u> 25
<u>SC7</u> 6,6,6,6,7	<u>CBR7</u> 23-24	<u>SC8</u> 6,5,7,7,8	<u>CBR8</u> 23-24	<u>SC9</u> 6,5,7,7,8	
<u>SC10</u> 7,7,7,7,7	<u>CBR9</u> 24-25	<u>SC11</u> 4,3,3,3,4	<u>CBR10</u> 24-25	<u>SC12</u> 6,5,6,7	<u>CBR11</u> 24-25
<u>SC13</u> 4,10,9,8,6	CBR13 <u>CBR13</u> 5-16. (wet) pond	<u>SC15</u> 3,6,5,5,4	<u>CBR14</u> 24-25	<u>SC16</u> 4,7,7,6,8	<u>CBR15</u> 25-26
<u>SC17</u> 9,9,8,8,8					
<u>SC18</u> 7,7,7,6,5	<u>CBR16</u> 25-26

- Legend**
-   24.04.23 CBR
 -   24.04.23 NDM
 -   24.04.23 Scala
 -   Untitled Image
 -   Site Boundary
 -   NDM Test

- All test have meet the threshold of required airvoids and Scale numbers.
- We recommend CBR of 9 for the road pavement design.
- OK to proceed.

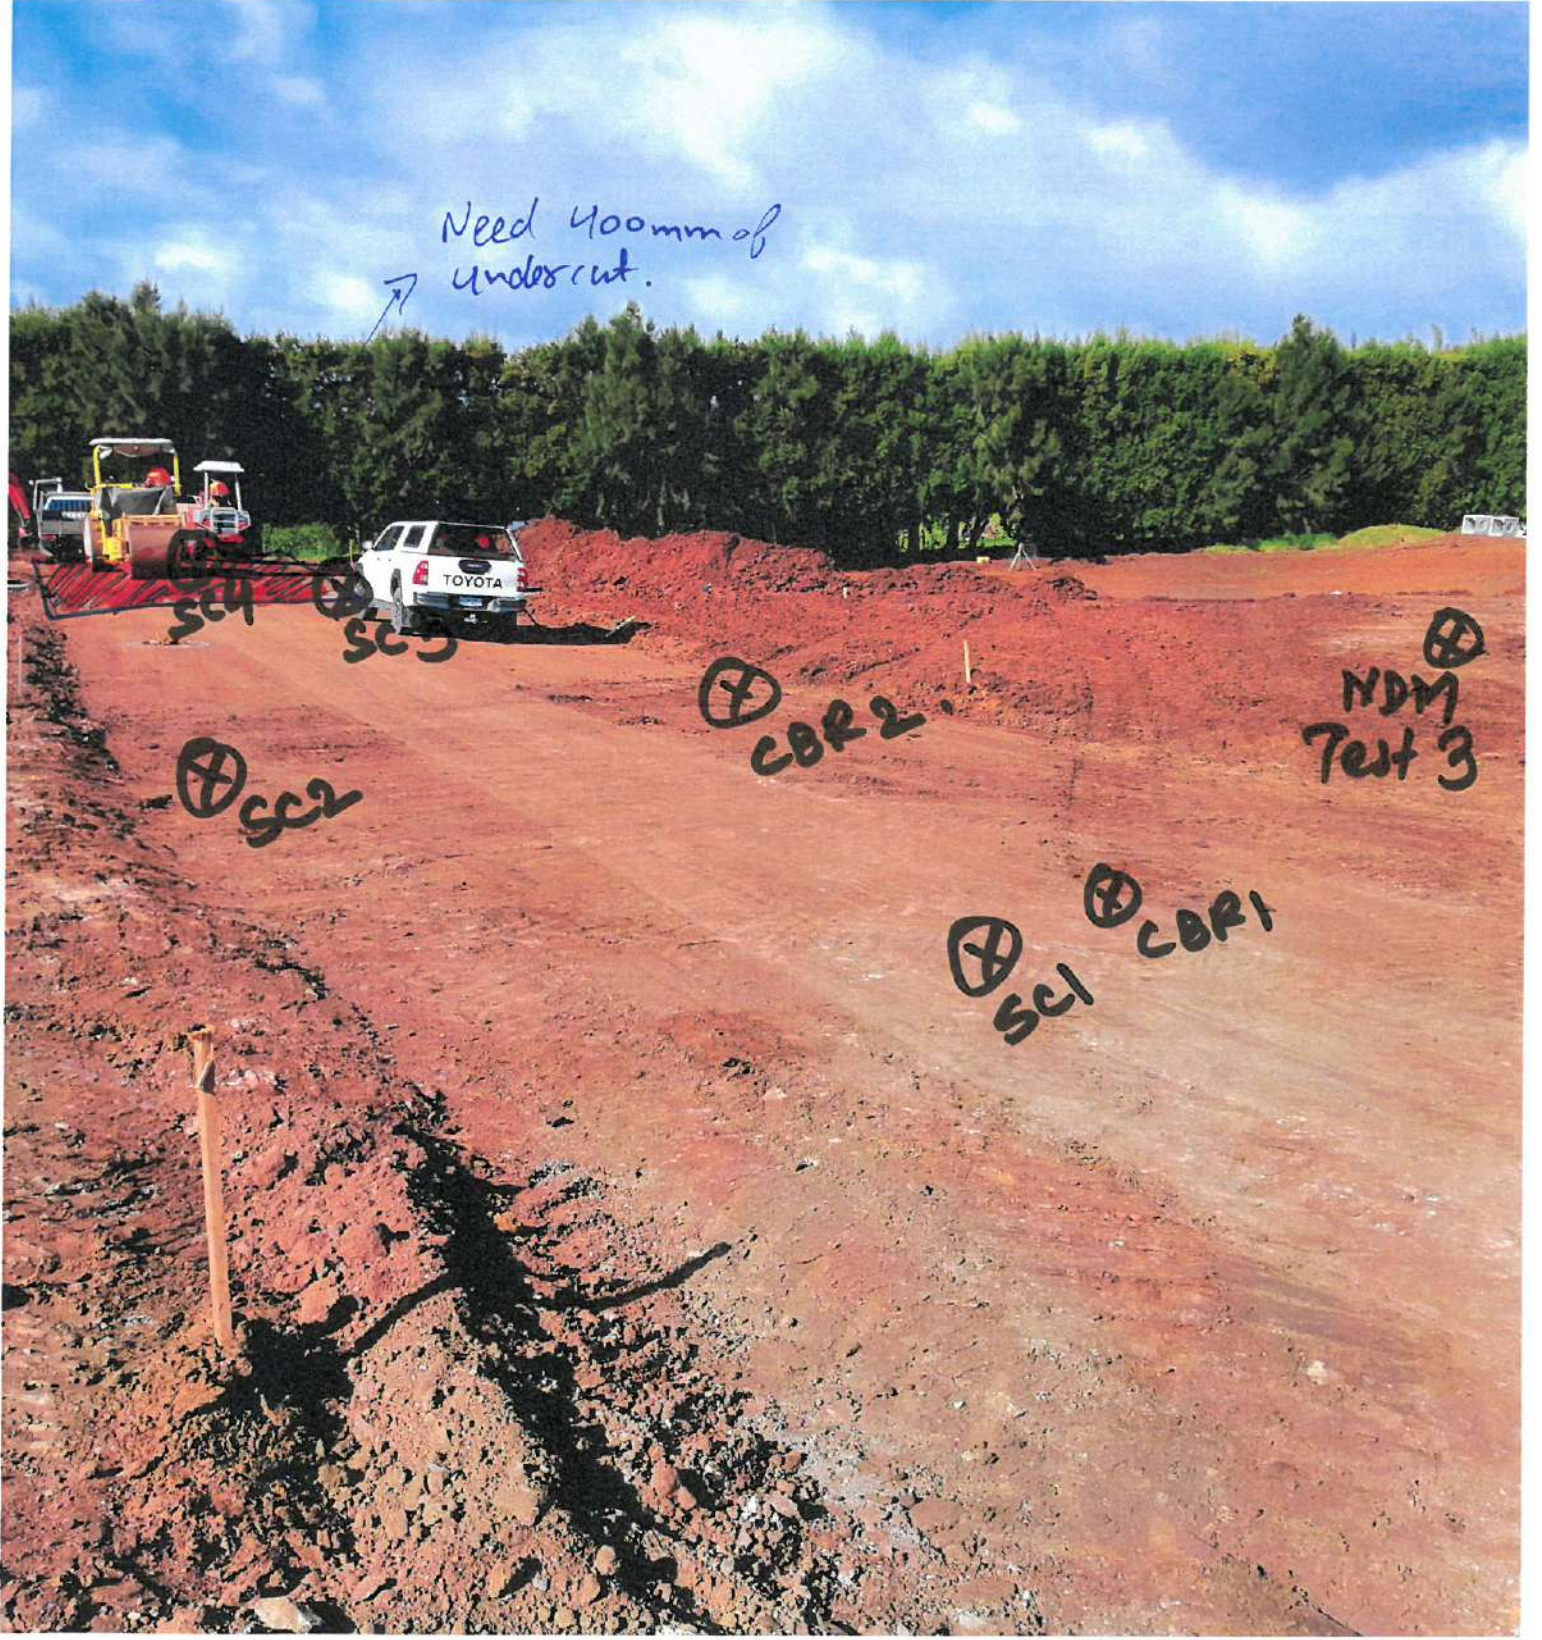
Need 400mm of undercut.

SC1

SC3

NDM Test 3

SC1 CBR1

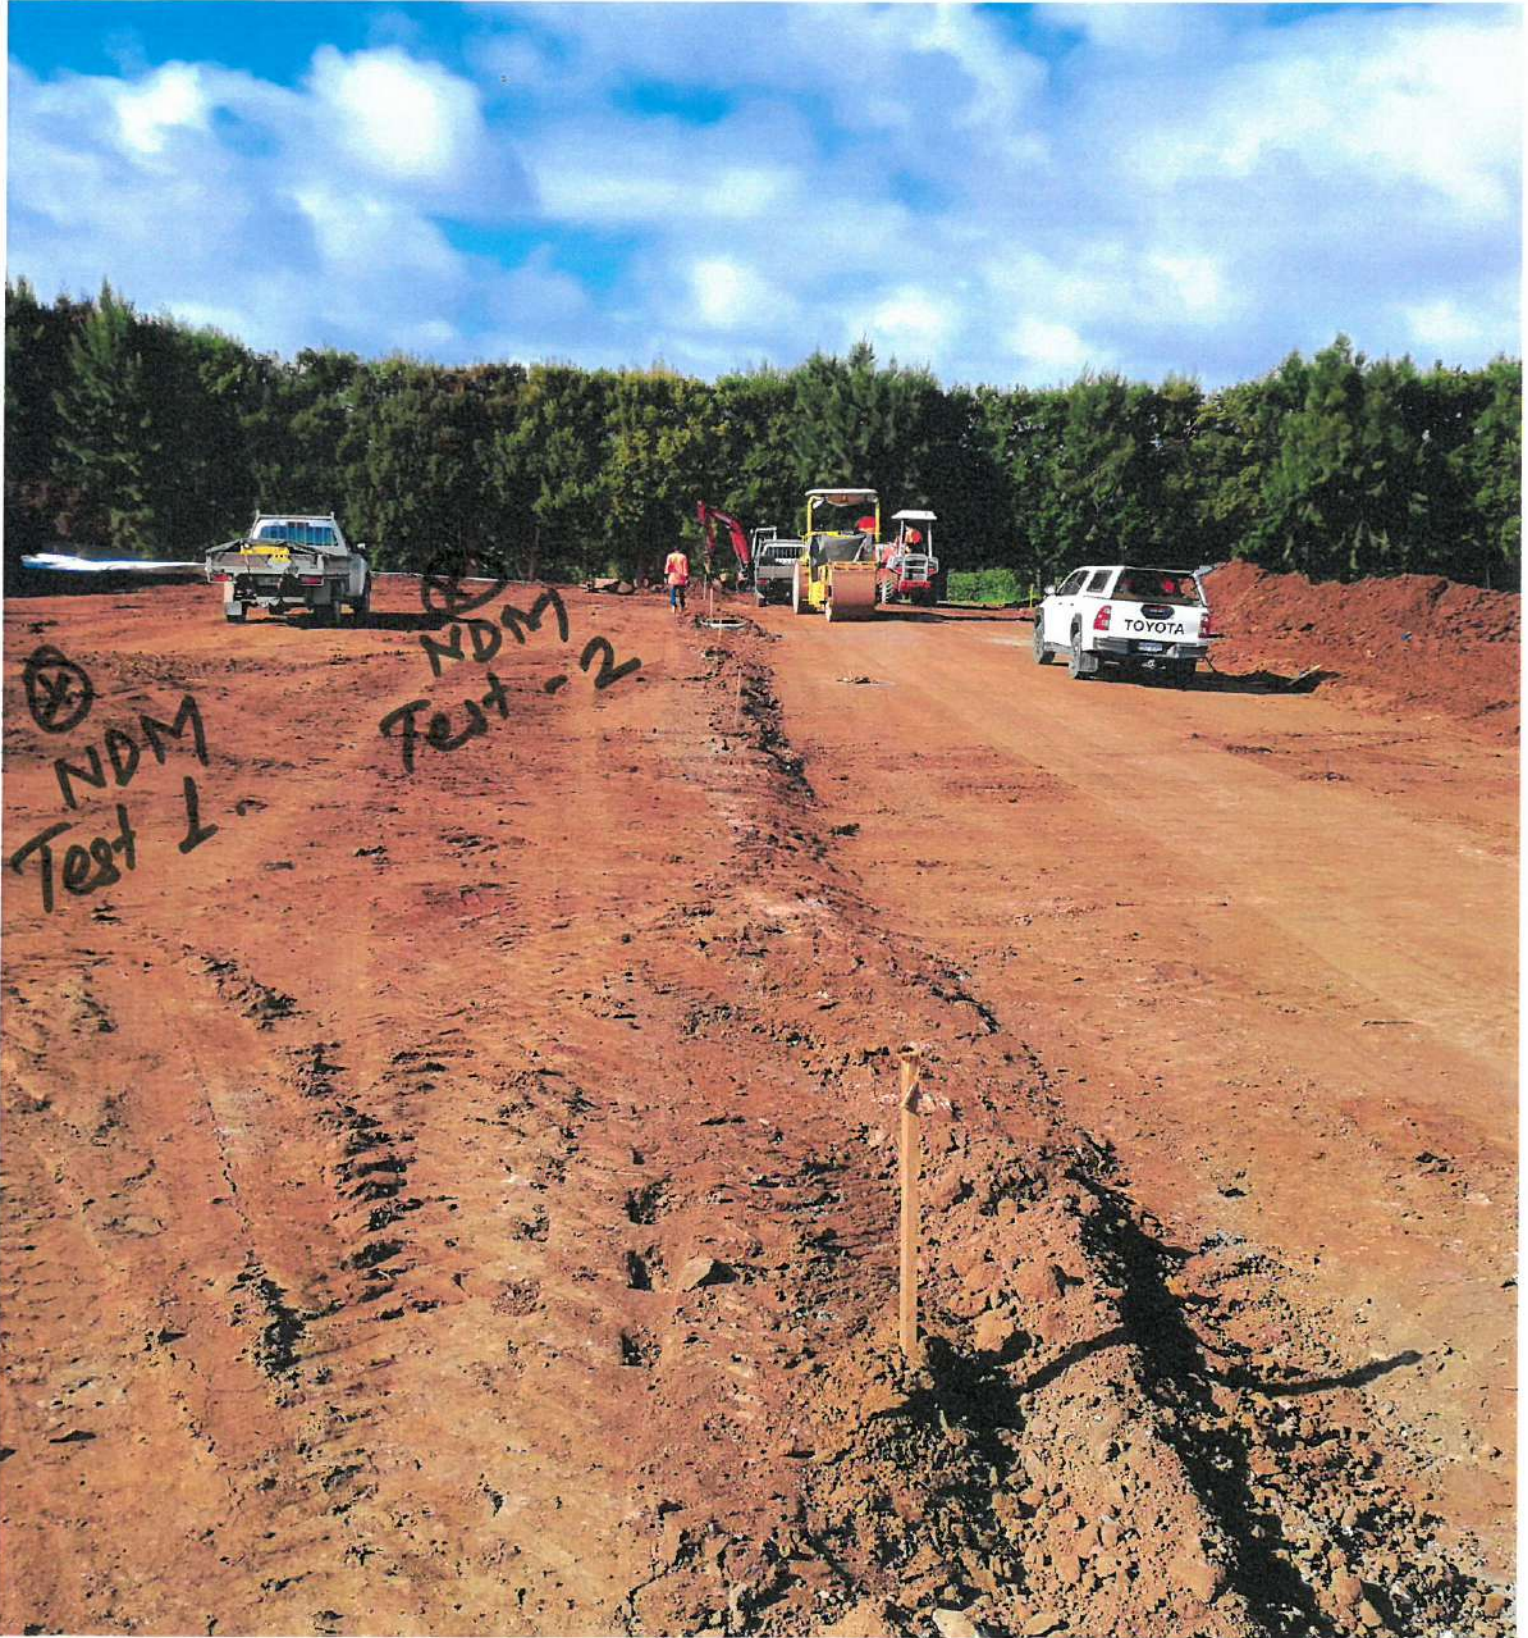
NDM test on fill over ~~west~~ eastern corner of site.
Most of the fill tested was pass, except of one area where it was too wet, failed in shear strength.

TS1, TS2, TS3, TS5 & TS6 were pass
TS4 failed due to low shear strength.

OK to proceed with the area passed.
Area failed ~~in~~ on site plan, needs to be stripped down to 0.5m to dry the soils and backfill again.

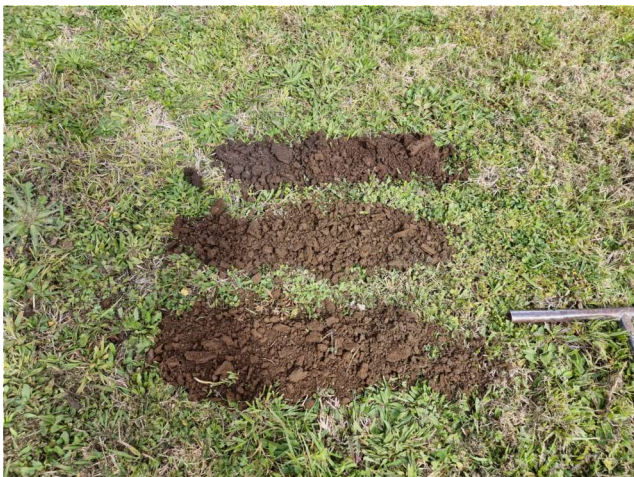
PHOTO / SKETCH

DEPTH (m)	SCALA (Blows / 100mm)	TESTS	GRAPHIC LOG	MATERIAL DESCRIPTION	WATER	DEPTH (m)
0.10				Topsoil: clayey SILT; dark brown, very stiff , moderately plastic , moist	Groundwater Not Encountered	
				silty CLAY; brown, hard , highly plastic , moist		
		SV = 125 / 51 kPa (GEO952)				
		SV = 161 / 59 kPa (GEO952)				
1		SV = 176 / 59 kPa (GEO952)				
		SV = 176 / 73 kPa (GEO952)				
		SV = 176 / 73 kPa (GEO952)				
		SV = 176 / 81 kPa (GEO952)				
2		SV = 161 / 73 kPa (GEO952)				
		SV = 176 / 88 kPa (GEO952)				
		SV = 176 / 73 kPa (GEO952)				
3		SV = 154 / 66 kPa (GEO952)		EOH: 3.00m

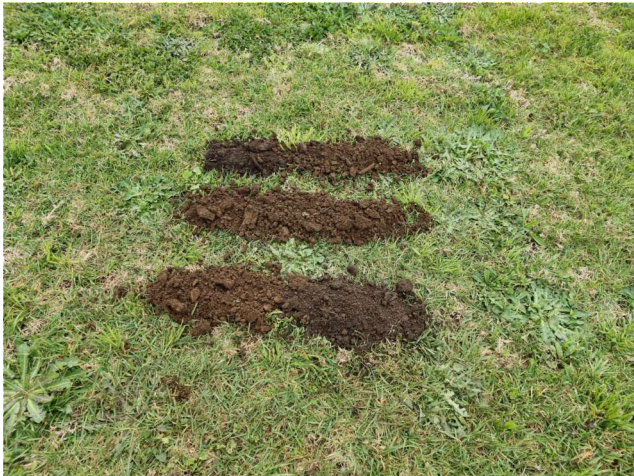
PHOTO / SKETCH

DEPTH (m)	SCALA (Blows / 100mm)	TESTS	GRAPHIC LOG	MATERIAL DESCRIPTION	WATER	DEPTH (m)
1		SV = 117 / 29 kPa (GEO952)		0.10 Topsoil: clayey SILT; dark brown, very stiff , moderately plastic , moist	Groundwater Not Encountered	
		SV = 161 / 59 kPa (GEO952)		silty CLAY; brown, very stiff , highly plastic , moist		
		SV = 161 / 73 kPa (GEO952)				
		SV = 176 / 81 kPa (GEO952)				
		SV = 176 / 88 kPa (GEO952)				
		SV = 161 / 59 kPa (GEO952)				
		SV = 147 / 59 kPa (GEO952)				
		SV = 147 / 59 kPa (GEO952)		2.50 clayey SILT; dark brown, very stiff , moderately plastic , moist		
		SV = 147 / 66 kPa (GEO952)				
		SV = 161 / 44 kPa (GEO952)		3.00 EOH: 3.00m

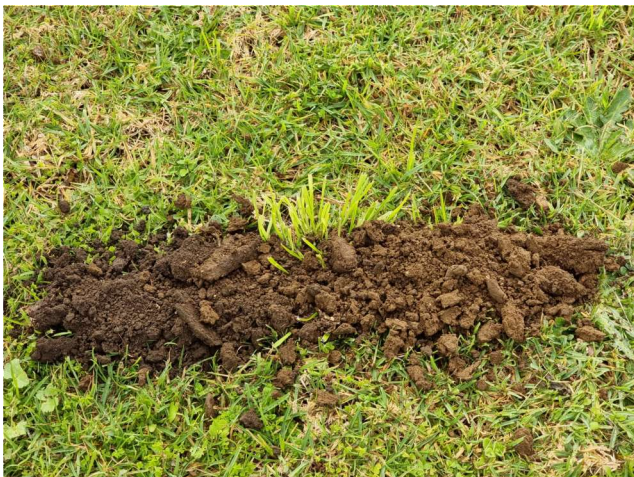
PHOTO / SKETCH

DEPTH (m)	SCALA (Blows / 100mm)	TESTS	GRAPHIC LOG	MATERIAL DESCRIPTION	WATER	DEPTH (m)
				Topsoil: clayey SILT; dark brown, very stiff , moderately plastic , moist 0.10 silty CLAY; brown, hard , highly plastic , moist	Groundwater Not Encountered	
1				1.00 EOH: 1.00m

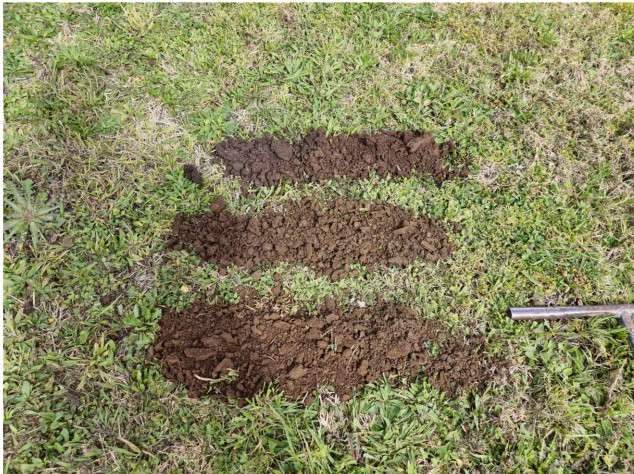
PHOTO / SKETCH

DEPTH (m)	SCALA (Blows / 100mm)	TESTS	GRAPHIC LOG	MATERIAL DESCRIPTION	WATER	DEPTH (m)
0.10				TOPSOIL		
				Silty CLAY, brown, very stiff, moist, highly plastic	Groundwater Not Encountered	
		SV = 125 / 51 kPa (GEO952)				
		SV = 161 / 59 kPa (GEO952)				
1		SV = 176 / 59 kPa (GEO952)				
		SV = 176 / 73 kPa (GEO952)				
		SV = 176 / 73 kPa (GEO952)				
2		SV = 176 / 81 kPa (GEO952)				
		SV = 161 / 73 kPa (GEO952)				
		SV = 176 / 88 kPa (GEO952)				
		SV = 176 / 73 kPa (GEO952)				
3				3.00 EOH: 3.00m		
		SV = 154 / 66 kPa (GEO952)

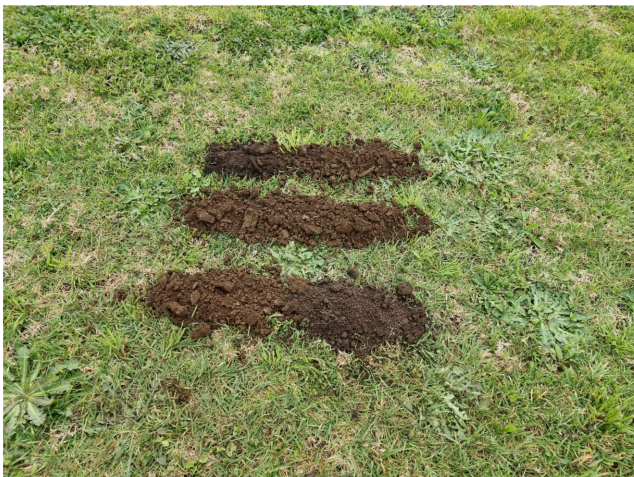
PHOTO / SKETCH

DEPTH (m)	SCALA (Blows / 100mm)	TESTS	GRAPHIC LOG	MATERIAL DESCRIPTION	WATER	DEPTH (m)
0.10				TOPSOIL		
		SV = 117 / 29 kPa (GEO952)		Silty CLAY, brown, very stiff, moist, highly plastic	Groundwater Not Encountered	
		SV = 161 / 59 kPa (GEO952)				
1		SV = 161 / 73 kPa (GEO952)				
		SV = 176 / 81 kPa (GEO952)				
		SV = 176 / 88 kPa (GEO952)				
2		SV = 161 / 59 kPa (GEO952)				
		SV = 147 / 59 kPa (GEO952)				
		SV = 147 / 59 kPa (GEO952)		2.50		
		SV = 147 / 66 kPa (GEO952)		Clayey SILT, dark brown, very stiff, moist, moderately plastic		
3		SV = 161 / 44 kPa (GEO952)		3.00 EOH: 3.00m

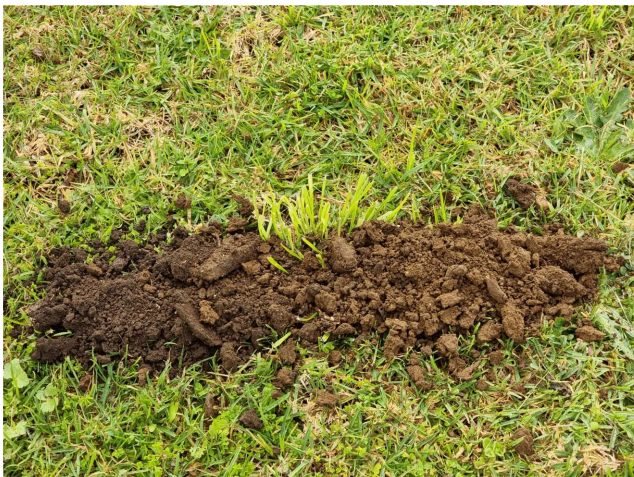
PHOTO / SKETCH

DEPTH (m)	SCALA (Blows / 100mm)	TESTS	GRAPHIC LOG	MATERIAL DESCRIPTION	WATER	DEPTH (m)
1			0.10	TOPSOIL	Groundwater Not Encountered	
			1.00	Silty CLAY, brown, hard, moist, highly plastic EOH: 1.00m		
2						
3

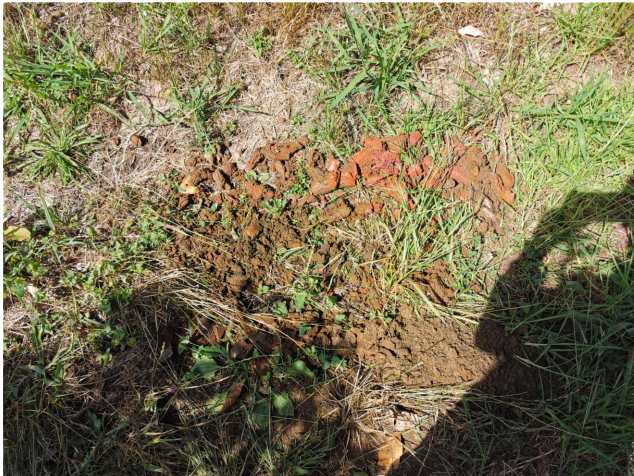
PHOTO / SKETCH

DEPTH (m)	SCALA (Blows / 100mm)	TESTS	GRAPHIC LOG	MATERIAL DESCRIPTION	WATER	DEPTH (m)
				0.10 TOPSOIL		
		SV = 233+ kPa (GEO287)		SILT, minor clay, brown, hard, moist, slightly plastic	Groundwater Not Encountered	
		SV = UTP (GEO287)		0.60 fine Sandy SILT, brown, hard, moist, non-plastic		
1		SV = UTP (GEO287)		1.00 SILT, trace clay, brown, very stiff, moist, slightly plastic		
		SV = 163 / 30 kPa (GEO287)		1.2m: Wet.		
		SV = 166 / 30 kPa (GEO287)				
2		SV = 186 / 17 kPa (GEO287)		1.8m - 2.0m: poor recovery		
		SV = 166 / 37 kPa (GEO287)		2.0m: Pink		
		SV = 103 / 70 kPa (GEO287)				
		SV = 189 / 50 kPa (GEO287)		2.70 Silty CLAY, purplish pink, very stiff, moist, highly plastic		
3		SV = 233+ kPa (GEO287)		3.00 EOH: 3.00m

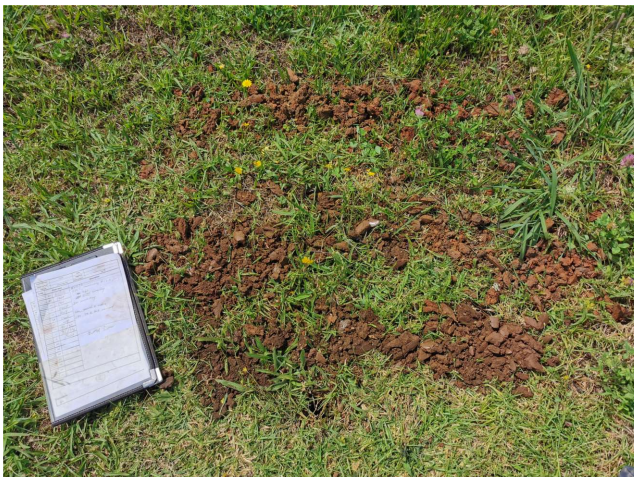
PHOTO / SKETCH

DEPTH (m)	SCALA (Blows / 100mm)	TESTS	GRAPHIC LOG	MATERIAL DESCRIPTION	WATER	DEPTH (m)
				0.10 TOPSOIL		
		SV = 103 / 37 kPa (GEO287)		SILT, minor clay, brown, hard, moist, slightly plastic	Groundwater Not Encountered	
		SV = 233+ kPa (GEO287)		0.7m: With some clay.		
1		SV = 233+ kPa (GEO287)		1.0m: With minor clay.		
		SV = 233+ kPa (GEO287)				
		SV = 233+ kPa (GEO287)		1.6m: Yellowish brown mottles		
2		SV = 233+ kPa (GEO287)		1.8m: Yellowish brown and dark brown intermixed		
		SV = UTP (GEO287)				
		SV = 154 / 53 kPa (GEO287)		2.4m: Very stiff.		
		SV = 153 / 56 kPa (GEO287)				
3		SV = 233+ kPa (GEO287)		3.00 EOH: 3.00m

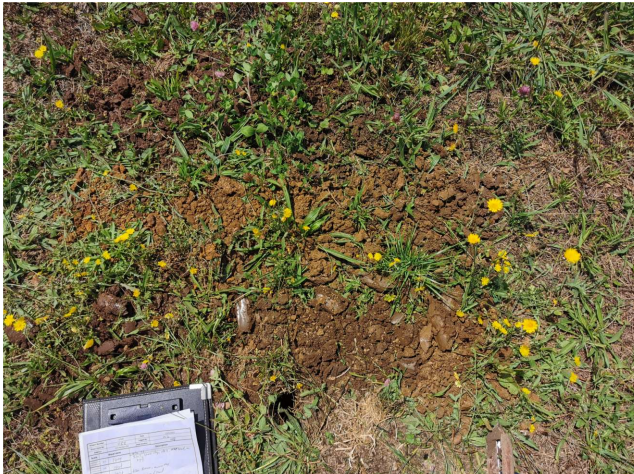
PHOTO / SKETCH

DEPTH (m)	SCALA (Blows / 100mm)	TESTS	GRAPHIC LOG	MATERIAL DESCRIPTION	WATER	DEPTH (m)
0.10				TOPSOIL		
		SV = 233+ kPa (GEO287)		SILT, some clay, dark brown, hard, moist, slightly plastic	Groundwater Not Encountered	
		SV = 233+ kPa (GEO287)				
1		SV = 233+ kPa (GEO287)		0.9m: With minor clay, Brown 1.0m: With minor fine sand		
		SV = 233+ kPa (GEO287)		1.3m: With some sand. Sand, fine.		
		SV = 233+ kPa (GEO287)		1.8m: With minor fine sand, dark brown		
2		SV = 228 / 83 kPa (GEO287)		2.3m: With some fine sand, trace clay and silt clusters		
		SV = 199 / 50 kPa (GEO287)				
		SV = 233+ kPa (GEO287)				
3		SV = UTP (GEO287)		3.00 EOH: 3.00m

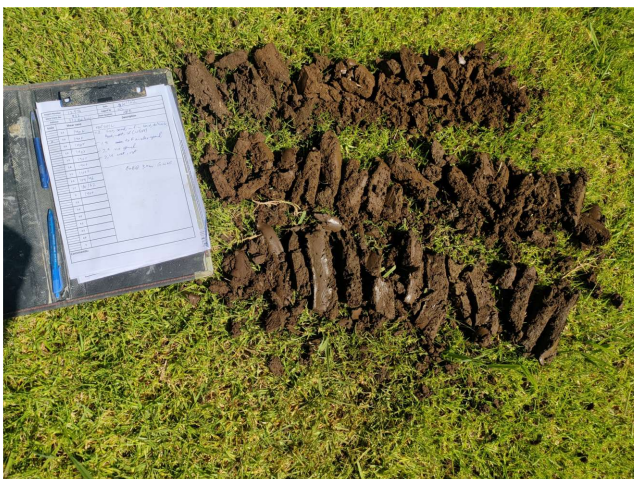
PHOTO / SKETCH

DEPTH (m)	SCALA (Blows / 100mm)	TESTS	GRAPHIC LOG	MATERIAL DESCRIPTION	WATER	DEPTH (m)
			TS	TOPSOIL		
			0.20			
		SV = 205+ kPa (GEO952)	/	SILT, some clay, minor fine to medium sand, dark orangish brown, hard, moist, slightly plastic	Groundwater Not Encountered	
		SV = 205+ kPa (GEO952)	/			
1		SV = 205+ kPa (GEO952)	/			
		SV = 205+ kPa (GEO952)	/			
		SV = 205+ kPa (GEO952)	/			
2		SV = 205+ kPa (GEO952)	/	1.8m: With trace gravel. Gravel, fine, angular.		
		SV = 205+ kPa (GEO952)	/	2.0m: Fine angular gravel absent		
		SV = 152 / 67 kPa (GEO952)	/	2.4m: Very stiff, wet.		
		SV = 161 / 76 kPa (GEO952)	/			
3				3.00 EOH: 3.00m		
		SV = 205+ kPa (GEO952)	/

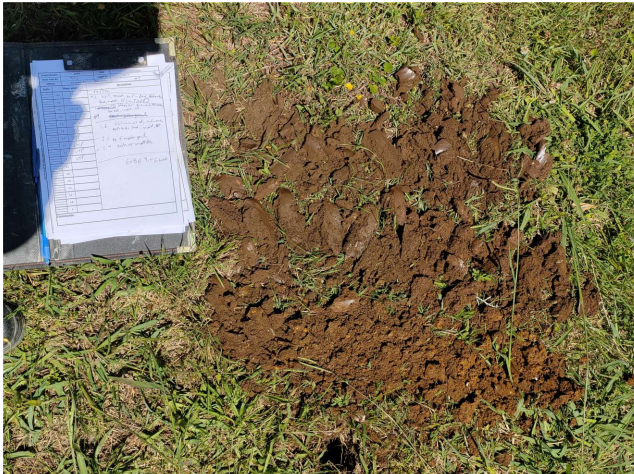
PHOTO / SKETCH

DEPTH (m)	SCALA (Blows / 100mm)	TESTS	GRAPHIC LOG	MATERIAL DESCRIPTION	WATER	DEPTH (m)
				TOPSOIL		
			0.20			
		SV = 205+ kPa (GEO952)		SILT, some clay, minor fine to medium sand, dark orangish brown, hard, moist, slightly plastic	Groundwater Not Encountered	
		SV = 205+ kPa (GEO952)				
1		SV = 205+ kPa (GEO952)				
		SV = UTP (GEO952)	1.20	Clayey SILT, minor fine to medium sand, dark orangish brown, hard, moist, moderately plastic		
		SV = 205+ kPa (GEO952)	1.60			
		SV = UTP (GEO952)		SILT, minor clay and fine to medium sand, dark orangish brown, hard, moist, non-plastic		
2		SV = UTP (GEO952)				
		SV = UTP (GEO952)				
		SV = UTP (GEO952)				
		SV = UTP (GEO952)				
3		SV = UTP (GEO952)	3.00	EOH: 3.00m

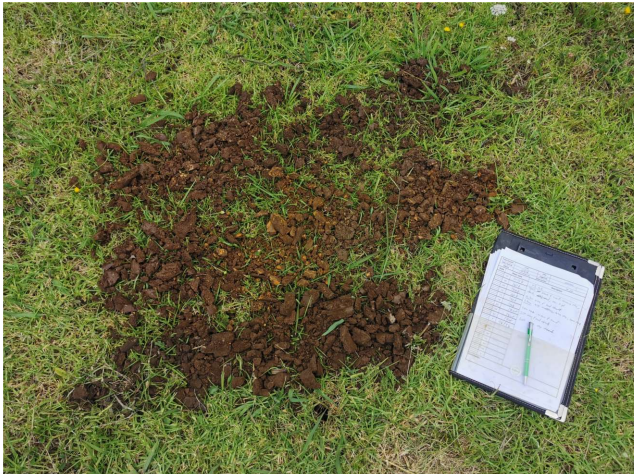
PHOTO / SKETCH

DEPTH (m)	SCALA (Blows / 100mm)	TESTS	GRAPHIC LOG	MATERIAL DESCRIPTION	WATER	DEPTH (m)
				TOPSOIL		
			0.20			
		SV = 166 / 45 kPa (GEO287)		SILT, some fine sand, minor clay, dark brown, hard, moist, slightly plastic	Groundwater Not Encountered	
		SV = 233+ kPa (GEO287)		0.7m: Some fine sand absent		
1		SV = 233+ kPa (GEO287)		1.3m: With some sand, with trace clay; orange mottles. Sand, fine.		
		SV = 233+ kPa (GEO287)		1.6m: With minor fine sand, wet		
2		SV = 233+ kPa (GEO287)		2.0m: Minor fine sand absent		
		SV = 233+ kPa (GEO287)		2.3m: Trace clay absent		
		SV = 233+ kPa (GEO287)				
		SV = 233+ kPa (GEO287)				
3		SV = 226 / 40 kPa (GEO287)		3.00 EOH: 3.00m

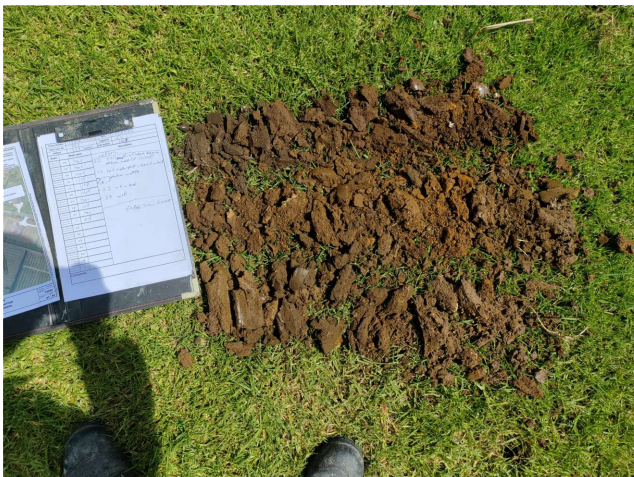
PHOTO / SKETCH

DEPTH (m)	SCALA (Blows / 100mm)	TESTS	GRAPHIC LOG	MATERIAL DESCRIPTION	WATER	DEPTH (m)
			TS	TOPSOIL		
			0.20			
		SV = 205+ kPa (GEO952)	/	SILT, some clay, minor fine to medium sand, dark orangish brown, hard, moist, slightly plastic	Groundwater Not Encountered	
		SV = 205+ kPa (GEO952)	/			
1		SV = 205+ kPa (GEO952)	/			
		SV = UTP (GEO952)	/	1.2m: With trace fine angular gravel		
		SV = UTP (GEO952)	/	1.6m - 1.8m: Dark orange mottles		
2		SV = 205+ kPa (GEO952)	/			
		SV = 205+ kPa (GEO952)	/	2.2m: With minor fine to medium sand		
		SV = UTP (GEO952)	/			
3		SV = 205+ kPa (GEO952)	/	2.9m: Wet		
		SV = UTP (GEO952)	/	3.00 EOH: 3.00m

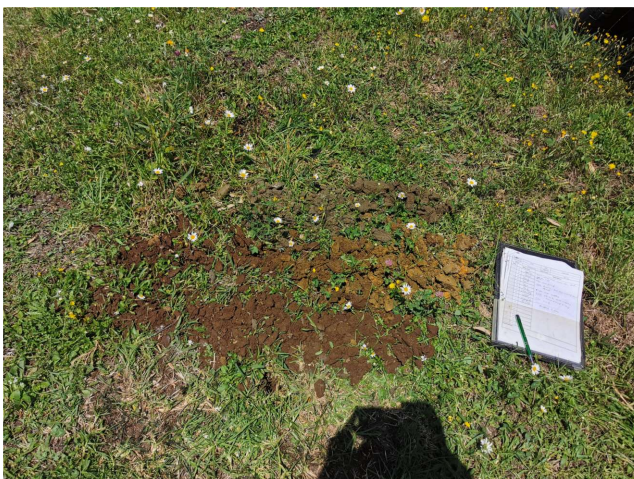
PHOTO / SKETCH

DEPTH (m)	SCALA (Blows / 100mm)	TESTS	GRAPHIC LOG	MATERIAL DESCRIPTION	WATER	DEPTH (m)
0.10			TOPSOIL			
		SV = 183 / 50 kPa (GEO287)		SILT, some fine sand, minor clay, dark brown, hard, moist, slightly plastic	Groundwater Not Encountered	
		SV = 233+ kPa (GEO287)		0.6m: With minor fine sand		
1		SV = 233+ kPa (GEO287)				
		SV = 233+ kPa (GEO287)				
		SV = 233+ kPa (GEO287)		1.5m: Minor fine sand and clay absent, Brown		
		SV = 233+ kPa (GEO287)		1.8m: Orange mottles		
2		SV = 223 / 164 kPa (GEO287)		2.2m: With minor fine sand and clay, Grayish brown, white mottles		
		SV = UTP (GEO287)		2.6m: Very stiff, wet		
		SV = 166 / 100 kPa (GEO287)				
3		SV = 158 / 83 kPa (GEO287)		3.00 EOH: 3.00m

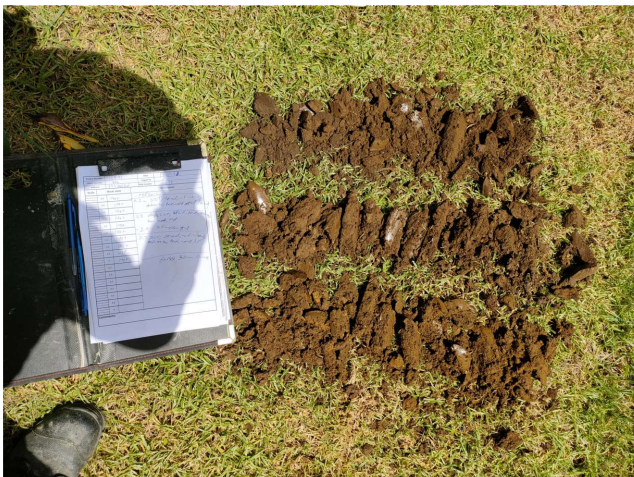
PHOTO / SKETCH

DEPTH (m)	SCALA (Blows / 100mm)	TESTS	GRAPHIC LOG	MATERIAL DESCRIPTION	WATER	DEPTH (m)
				TOPSOIL		
			0.20			
		SV = 205+ kPa (GEO952)		SILT, some clay, minor fine to medium sand, dark orangish brown, hard, moist, slightly plastic	Groundwater Not Encountered	
		SV = 205+ kPa (GEO952)				
1		SV = 205+ kPa (GEO952)				
		SV = 205+ kPa (GEO952)	1.20	Clayey SILT, trace fine to medium sand, dark orangish brown, hard, moist, moderately plastic		
		SV = 205+ kPa (GEO952)				
		SV = 205+ kPa (GEO952)				
2		SV = 205+ kPa (GEO952)	2.0m: With trace fine angular gravel			
		SV = 205+ kPa (GEO952)	2.20			
		SV = 205+ kPa (GEO952)		SILT, some clay, minor fine to medium sand, dark orangish brown, hard, moist, slightly plastic		
		SV = UTP (GEO952)				
3		SV = 205+ kPa (GEO952)	3.00	EOH: 3.00m

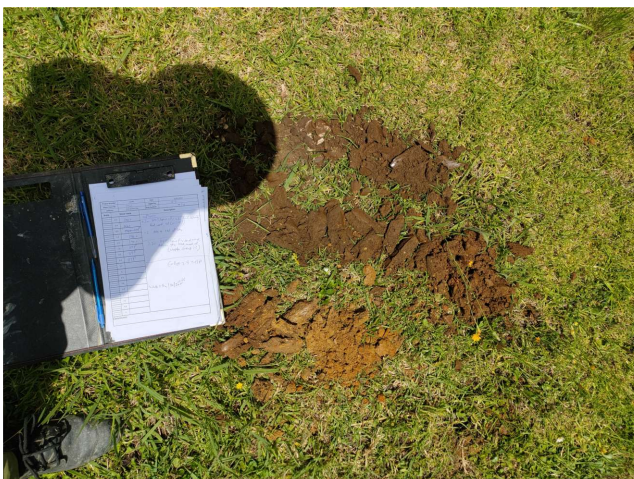
PHOTO / SKETCH

DEPTH (m)	SCALA (Blows / 100mm)	TESTS	GRAPHIC LOG	MATERIAL DESCRIPTION	WATER	DEPTH (m)
			TS	TOPSOIL		
			0.20			
		SV = 205+ kPa (GEO952)		SILT, some clay, minor fine to medium sand, dark orangish brown, hard, moist, slightly plastic (Kerikeri Volcanic Group)	Groundwater Not Encountered	
		SV = 205+ kPa (GEO952)				
1		SV = UTP (GEO952)				
		SV = 205+ kPa (GEO952)		1.6m: Dark and red mottles		
		SV = 205+ kPa (GEO952)				
2		SV = UTP (GEO952)		2.20		
		SV = UTP (GEO952)		2.50		
	20		EOH: 2.50m			
	20					
3

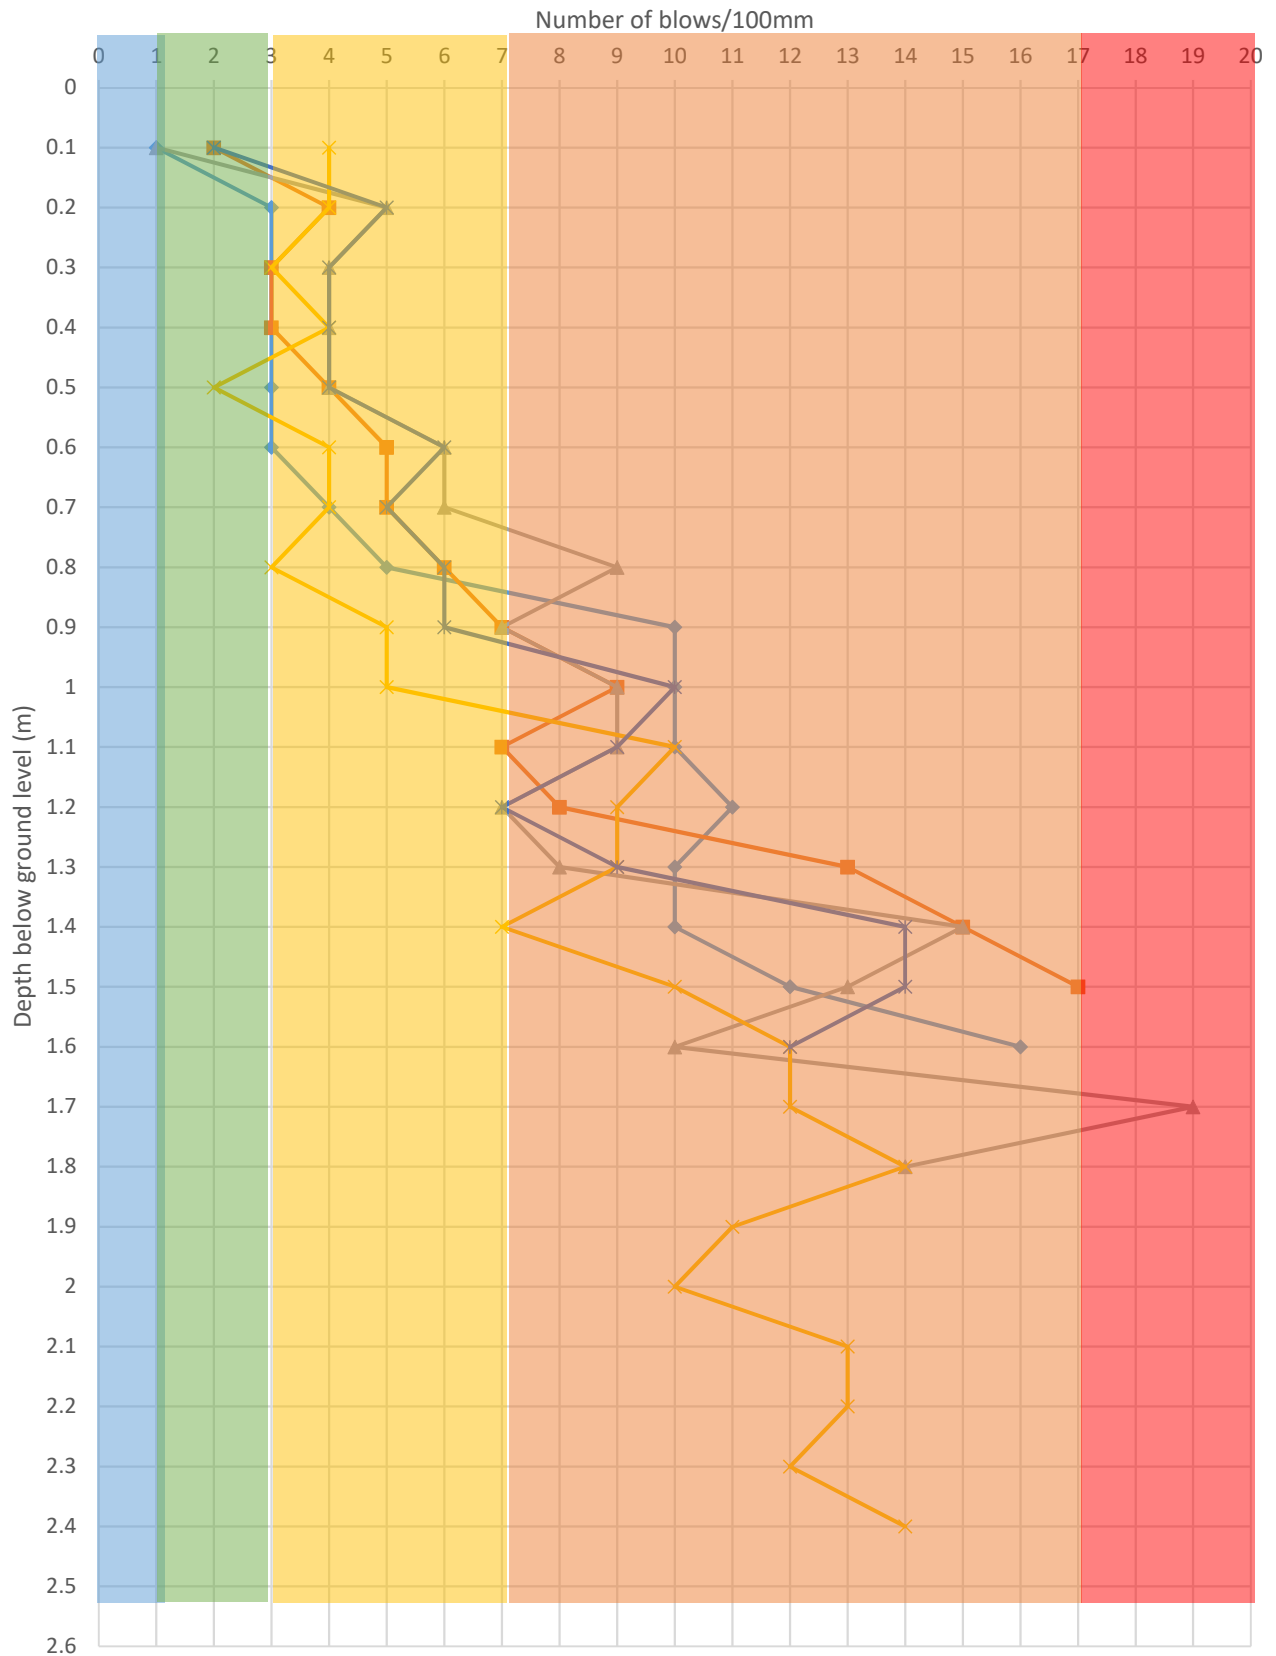
SP01 - SP05 Raw Data in Natural Ground Blows/100 mm

Legend: Very Loose =
Loose =
Medium Dense =
Dense =
Very Dense =

A loose soil layer was encountered from 3.3m to 3.8m in HA06, measured via Scala testing, with values between 1 and 2 blows per 100mm penetration. This layer was not encountered in any other test locations over the site and is considered discontinuous.
