EARTHWORK COMPLETION REPORT

PREPARED FOR TRAVERSE LTD

AT 373 KERIKERI ROAD, KERIKERI

LOT 1 DP 25752

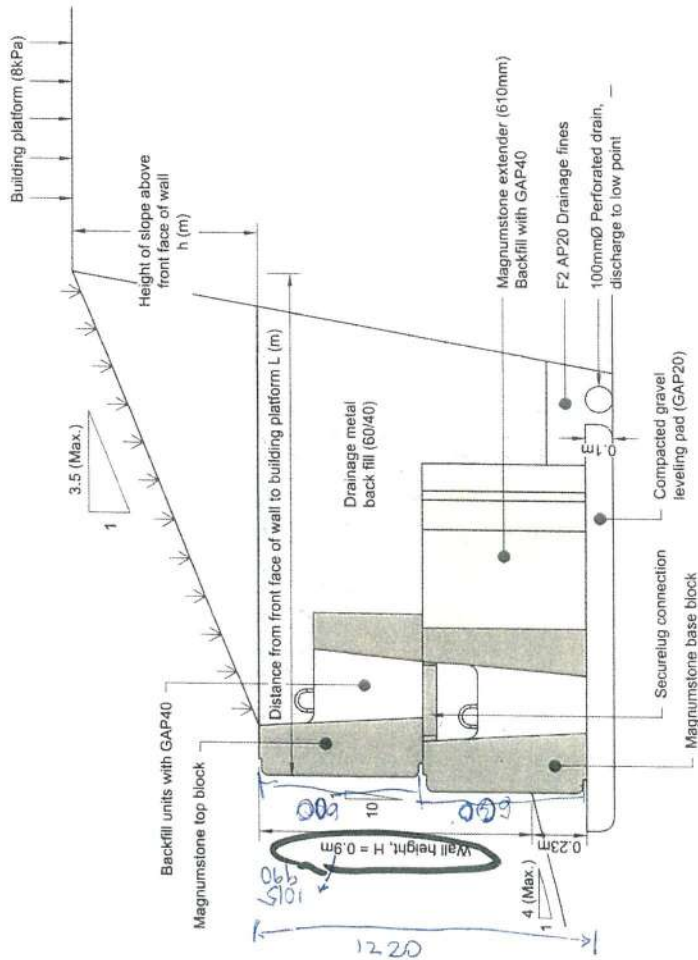
TYPICAL RETAINING WALL CROSS SECTION - WITH EXTENDER BLOCK
NOT TO SCALE
(WALLS A, B, C, F & H)

Wall	L (m)	h (m)
A	1.25	0.4
B	1.25	0.4
E	1.25	0.4
G	1.5	0.4

1. THE DIMENSIONING OF THE WALLS SHALL NOT BE MODIFIED DURING FUTURE DEVELOPMENT WITHOUT CONSULTING THE DESIGN ENGINEER, I.E CHANGING THE L (M) DIMENSION OR SHIFTING SURCHARGE LOAD CLOSER TO THE WALL.
2. THE MAGNUMSTONE UNITS ARE MODULAR AND SHOULD FUTURE DEVELOPMENT PROPOSE MODIFYING SITE CONDITIONS, THE WALL WILL ENABLE MODIFICATION (ADDITIONAL BLOCKS/EXTENDERS) TO CATER TO DESIGN LOAD CHANGES. THIS SHALL BE SUBJECT TO SPECIFIC ENGINEERING DESIGN.

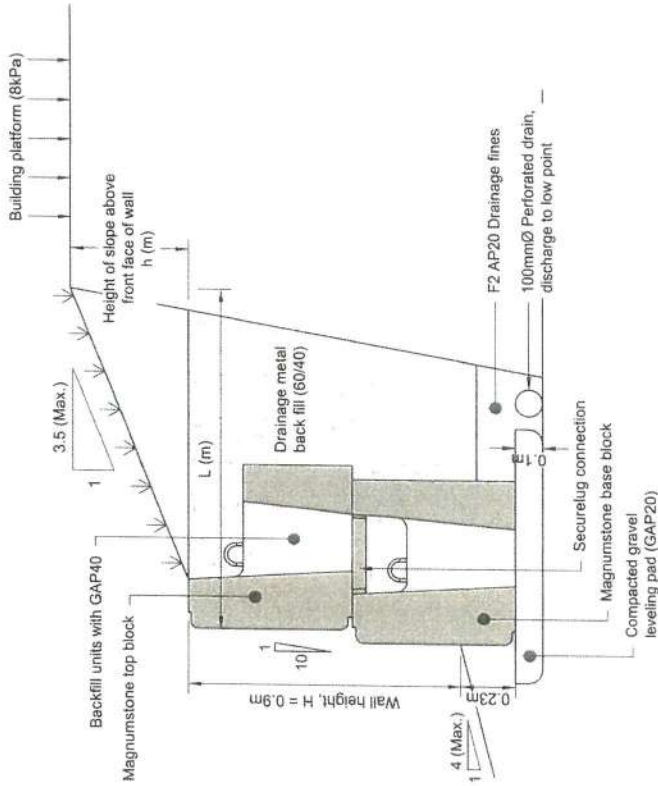
TYPICAL RETAINING WALL CROSS SECTION - WITHOUT EXTENDER BLOCK
NOT TO SCALE
(WALLS D, E & G)

Wall	L (m)	h (m)
C	2.0	0.6
D	1.75	0.5
F	2.25	0.65
